**GOVERNMENT OF INDIA
NORTH EASTERN COUNCIL SECRETARIAT
NONGRIM HILLS, SHILLONG – 793003**

Subject: Forwarding of Inspection Report.

Report of the inspection carried out on 30/04/2018 for the NEC funded project “Construction of Auditorium and Compound Wall of Sainik School Imphal, Manipur”.

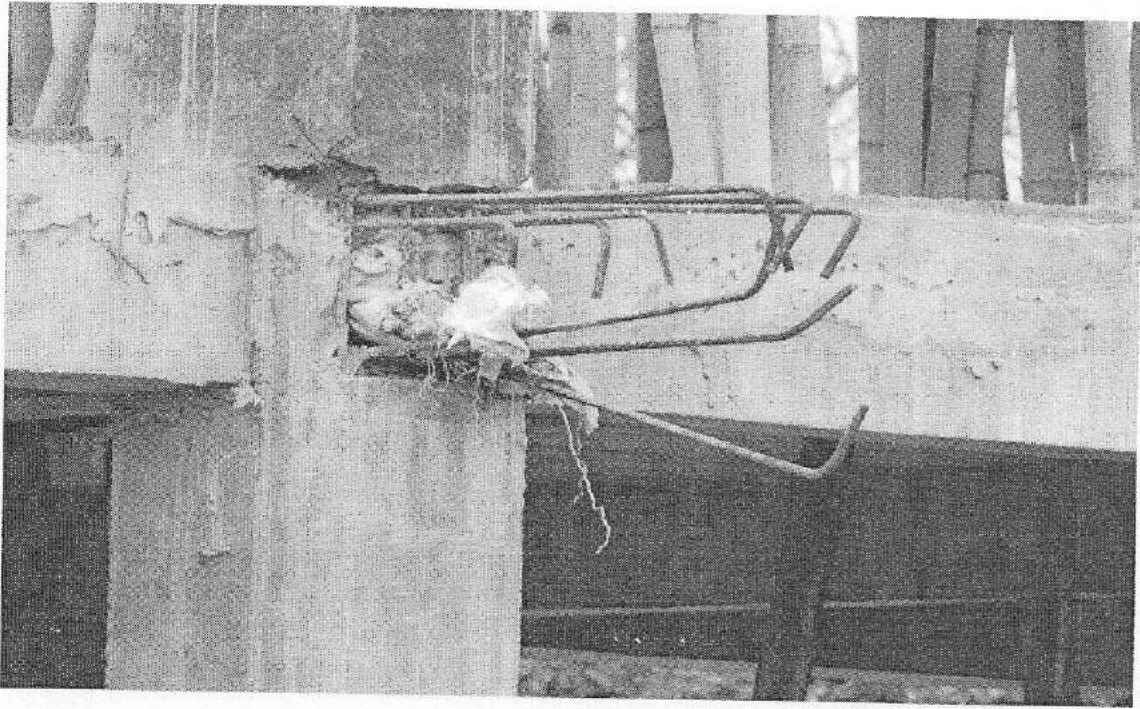
- It was found that in some columns the reinforcement bars are exposed to the atmosphere thus this will cause corrosion in the reinforcement bars and also reduce it strength. Photograph enclosed.

Photo showing poor quality of work. Reinforcement of columns exposed.

- The quality of work was not upto the mark and the mix used for concreting work was not satisfactory. The Implementing department should conduct a non destructive test on all the columns, beams and slabs of the auditorium building at the project site so as to make sure that the building is safe to withstand a huge amount of load.

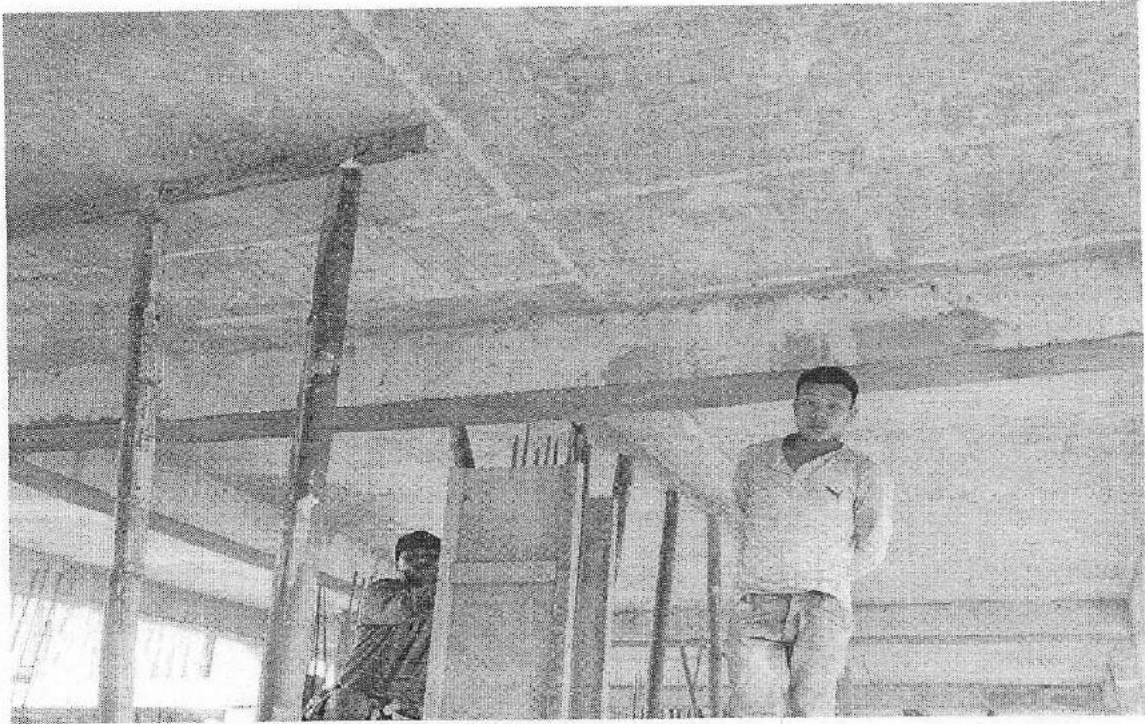
- It could be seen that cracks has occurred in beams of the building and also it was found that many extra columns were constructed at site. The Implementing department informed that these extra columns will help support the beams which have a slight deflection at its mid span.

Photo of the extra column constructed to support a deflected beam.

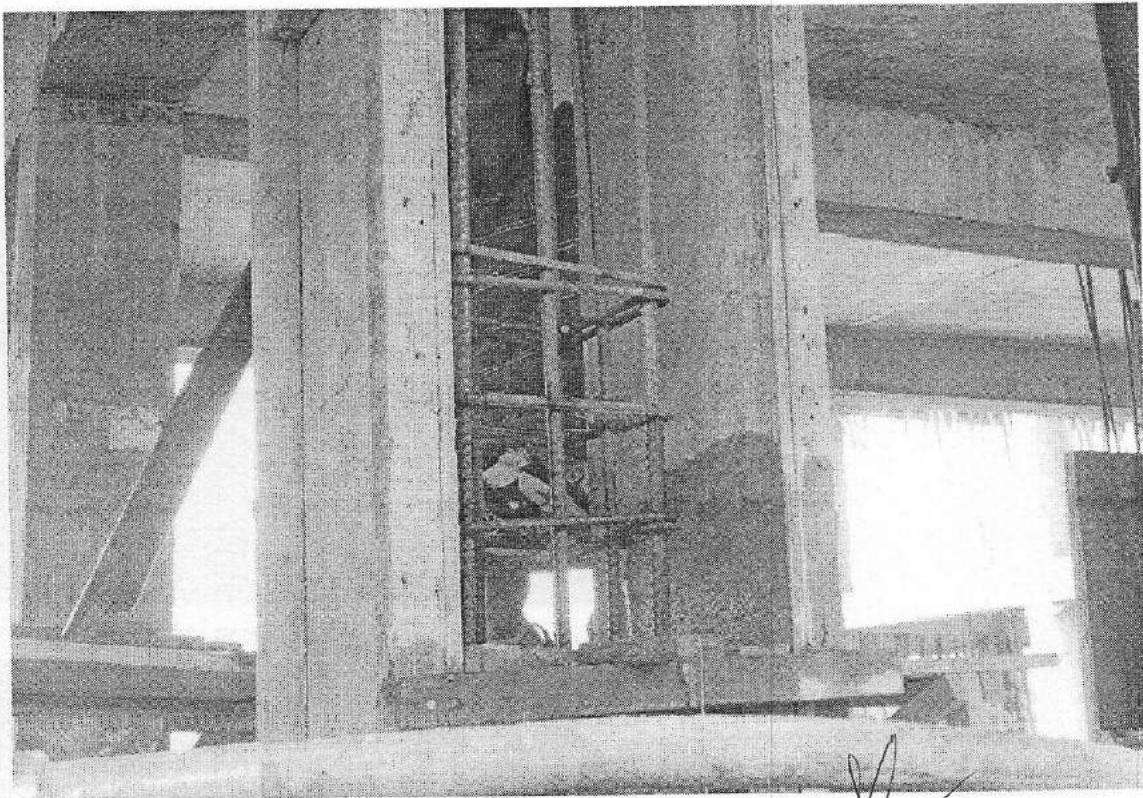
Photo of reinforcements used for extra columns.

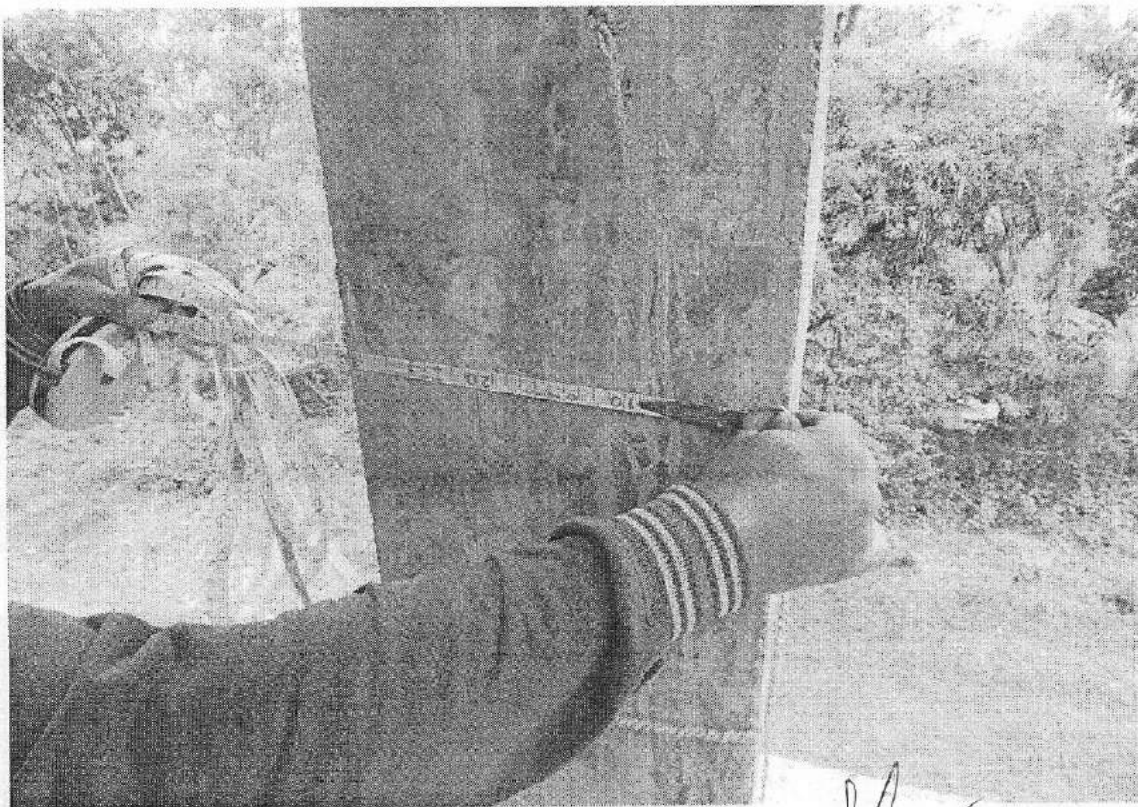
- The Size of columns provided for columns C2 at site was 30cm x 30cm which was not as per specification mentioned in approved DPR. The reinforcement used for columns C2 at site was 4 nos. of 16mm dia bars and 4 nos. of 12mm dia bars which was also not as per specification mentioned in approved DPR. The Implementing department should clarify as to why they reduce the size of both columns and reinforcement bars and also how the columns constructed at site will bear the huge load coming on them when the size of columns and bars were compromised.

Photo showing Column size

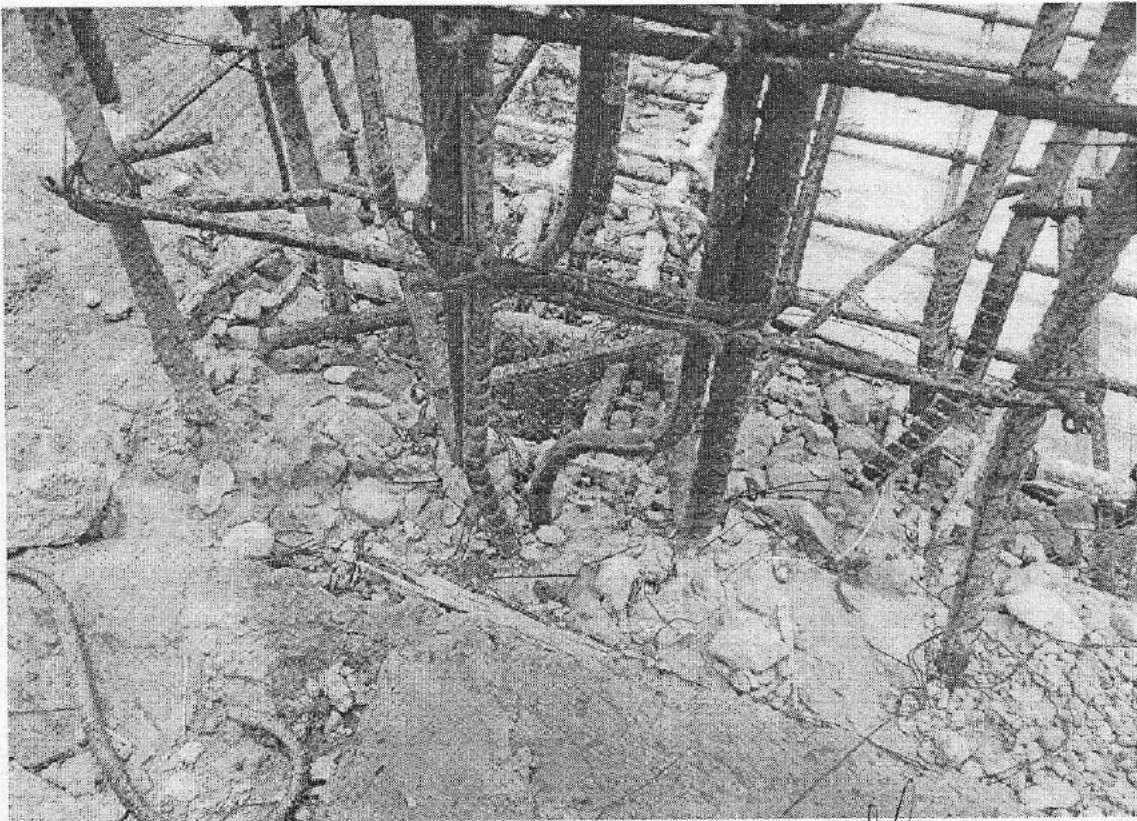
Photo of the reinforcement in columns are being bend.

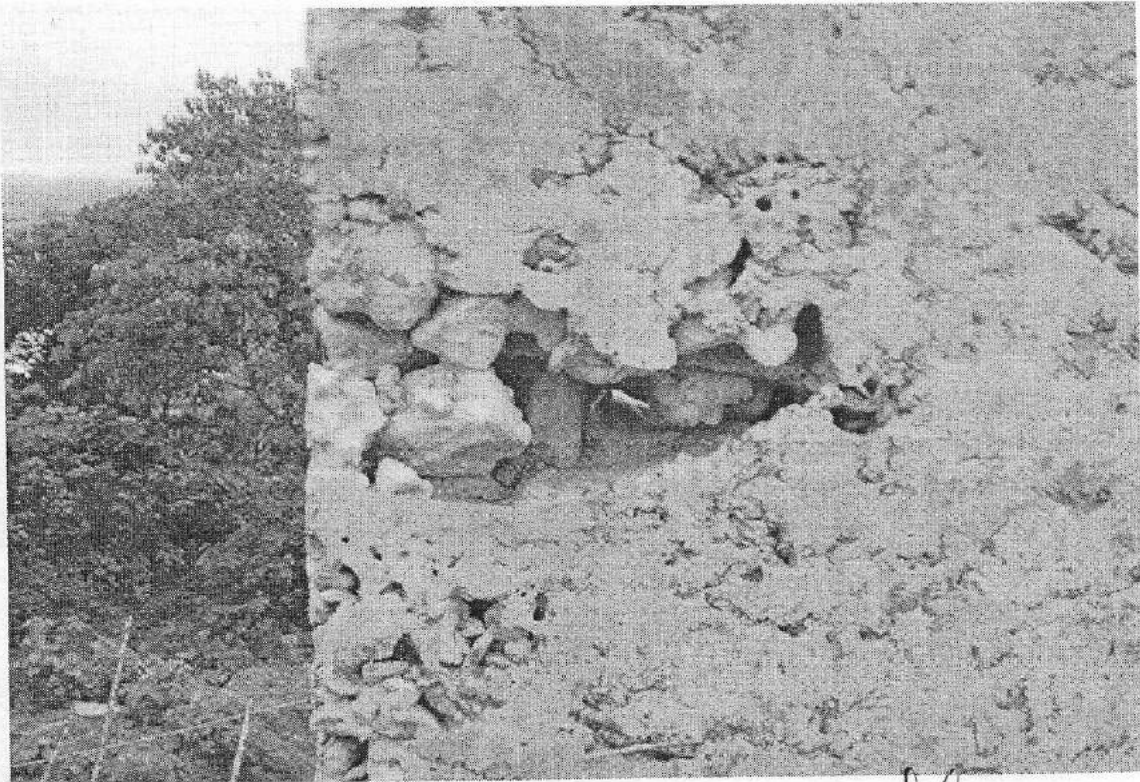
Photo showing the quality of casting in a column. Reinforcement exposes.

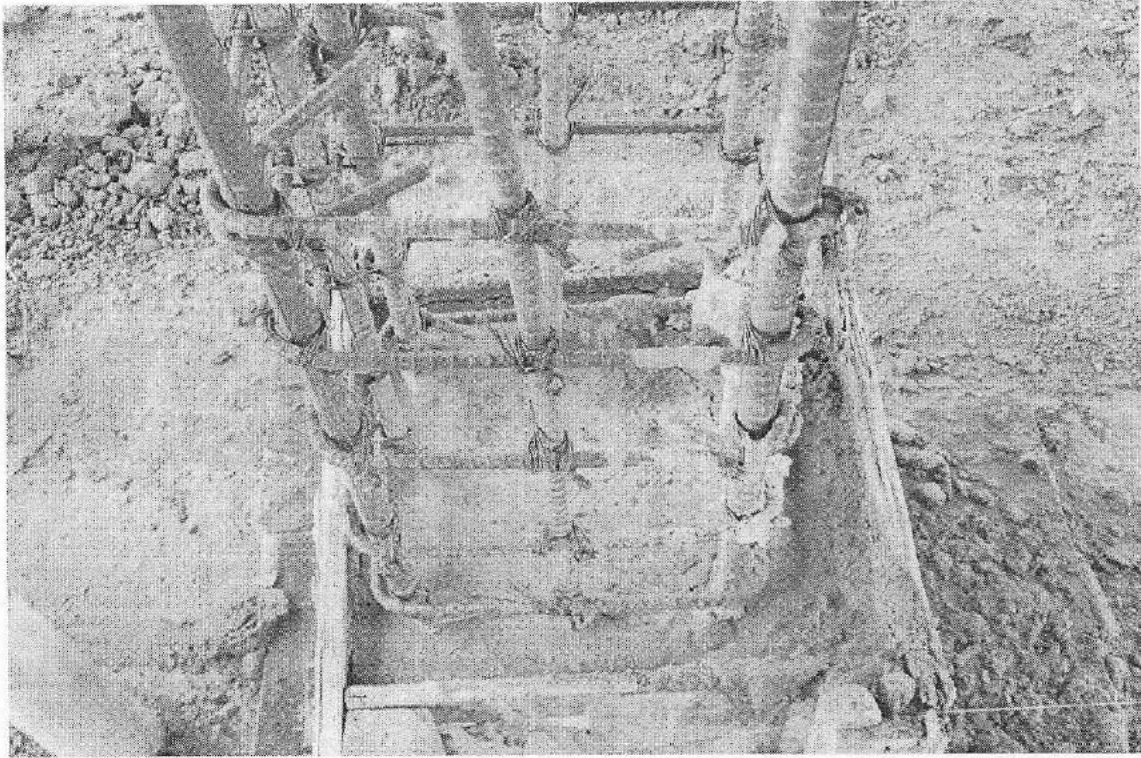
Photo of the column showing the cover in columns.

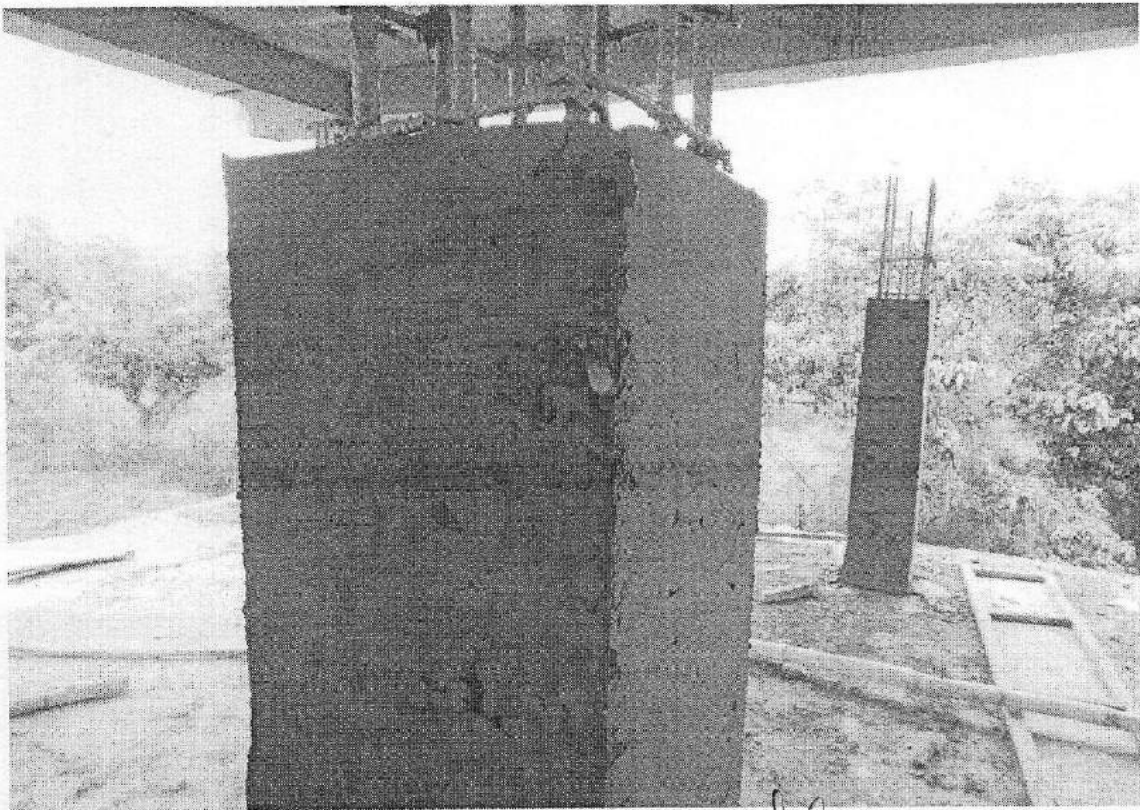
Photo showing poor quality of work.

- The Implementing department should obtained a certificate from a Structural engineer of a reputed Institute such as NIT or IIT stating that the structural frame (i.e. columns, beams and slab) of the auditorium can bear the huge load coming on them and that the building will not fail structurally.

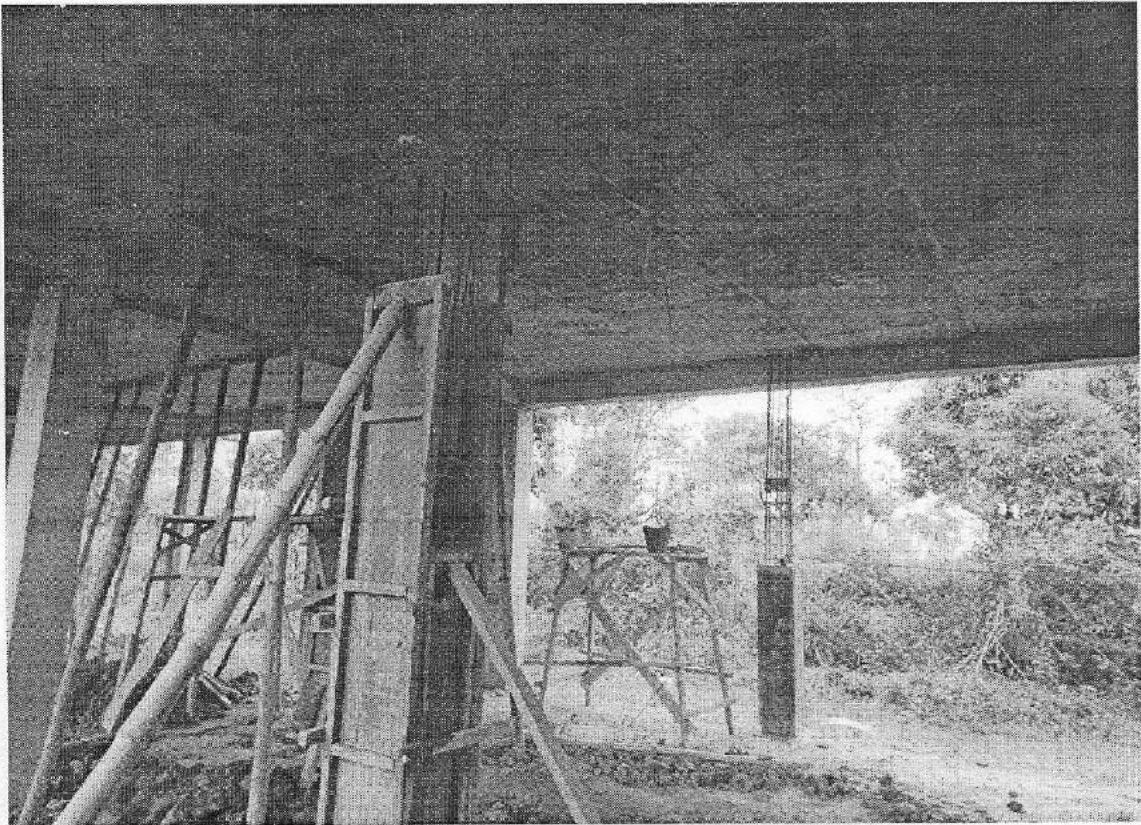
Photo of extra columns

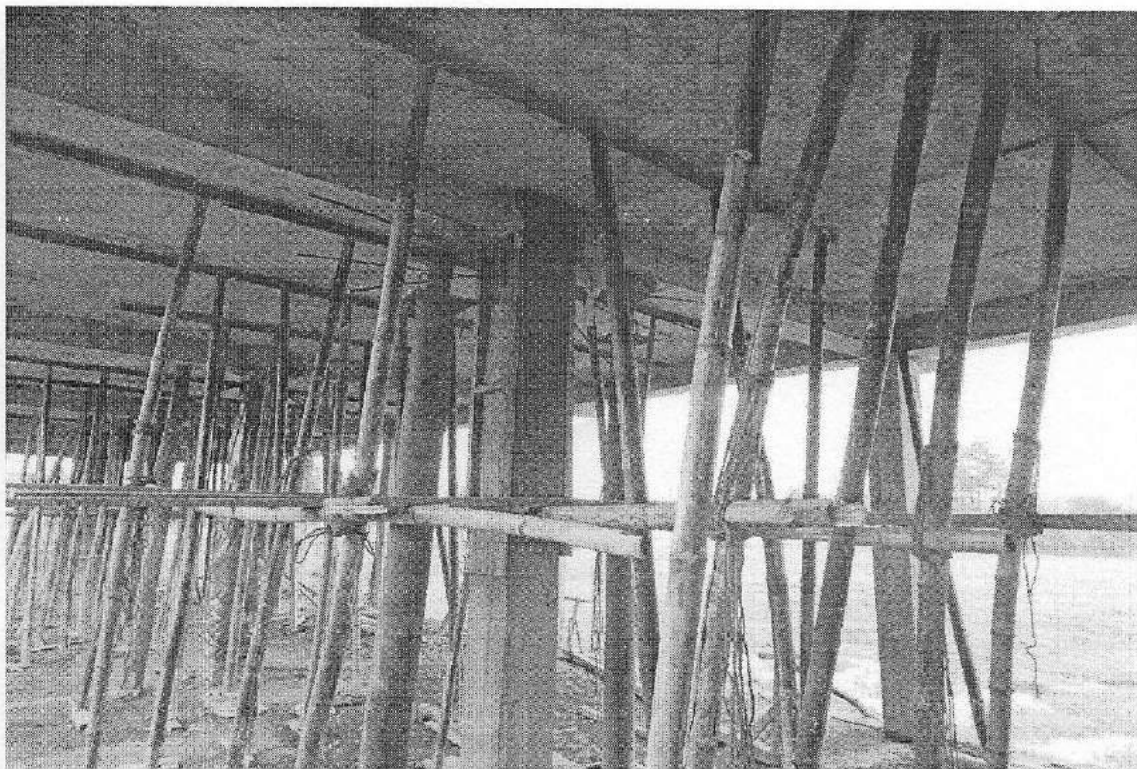
The photo showing extra column connected to the beam.
