**GOVERNMENT OF INDIA  
NORTH EASTERN COUNCIL SECRETARIAT  
NONGRIM HILLS, SHILLONG – 793003**

**Subject: Forwarding of Inspection Report.**

**Report of the inspection carried out on 18/02/2018 for the NEC funded project "Construction of Outdoor Stadium at Rijo Ground, Daporijo, Upper Subansiri District, Arunachal Pradesh".**

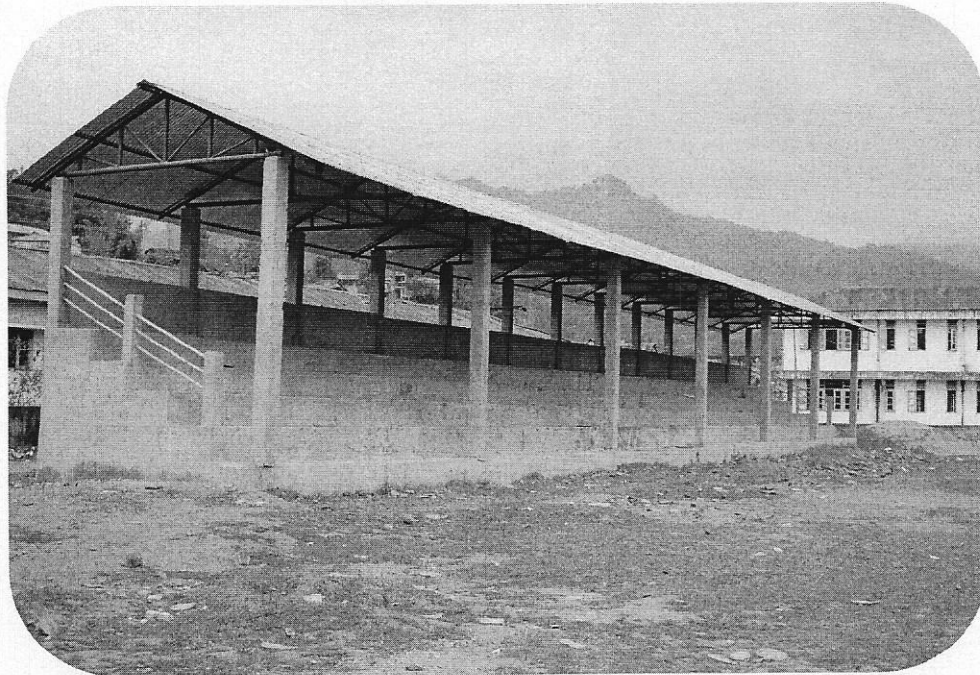
Sl. No.	Scope of Work as per Administrative Approval	Approved cost of NEC (in Rs.)	Observations & Remarks
1.	RCC covered Gallery (320M x 5.30M).	1,93,17,440	<ul style="list-style-type: none"><li>• The Consultants had inspected the site and found that the total length of the gallery constructed at site till date was 144m and a length of approximately 176m was still pending. The executing agency informed that the remaining length of about 176m would be completed as soon as they received the final installment. It could be seen during inspection that the galleries adjacent to the rostrum had been constructed, fixing of truss and CGI Sheet Roofing had been done; sitting area inside the galleries, erecting of columns and plastering works had been done. Finishing works such as painting works was still pending.</li><li>• The galleries opposite to the rostrum were still under construction and it was found that the excavation works, laying of footing, erecting of wall in all four sides of the galleries had been done. Erecting of reinforcements for columns and filling of earth for sitting area were in progress.</li><li>• The inspection team could not give any comments on the size and reinforcements used for columns at site because the detail drawings were not provided in the approved DPR.</li><li>• The Implementing department should complete the project as per specification mentioned in approved DPR.</li></ul>

View of Gallery

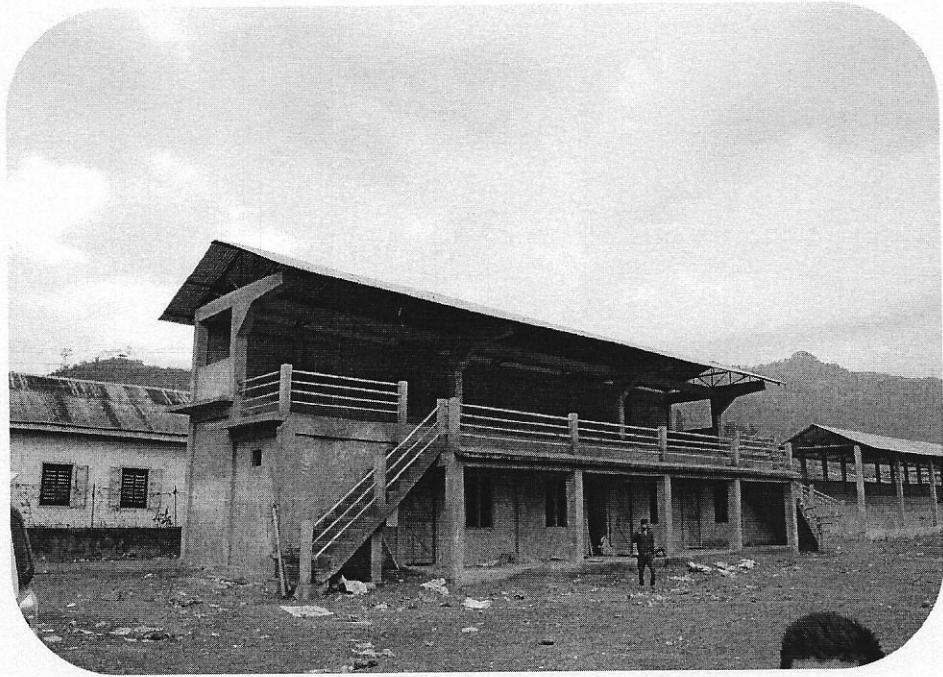
View of Rostrum

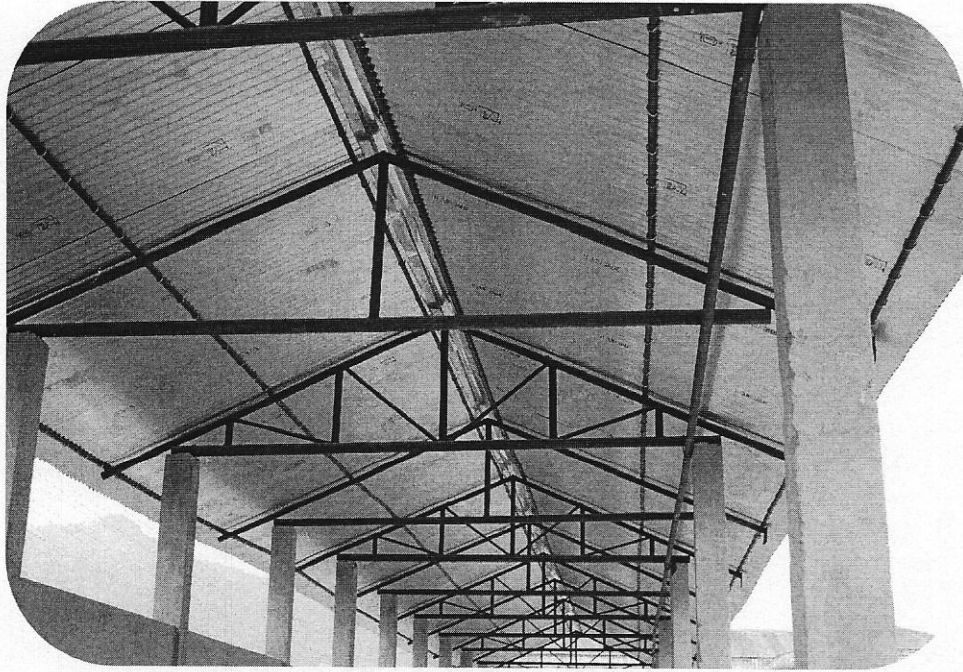
View of truss and GI sheet

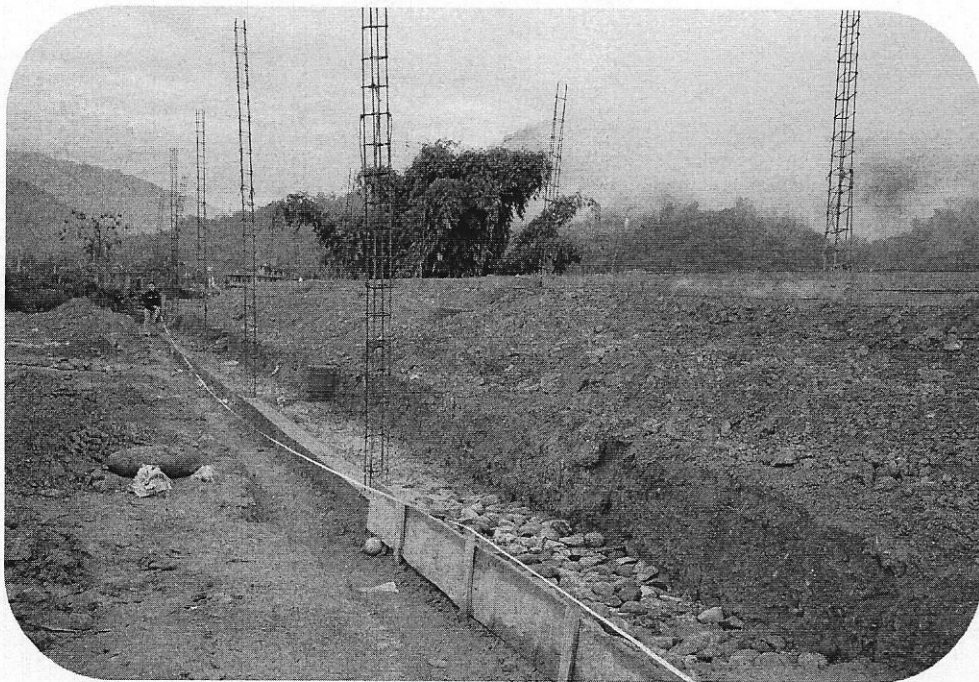
- During inspection it could be seen that the works were in progress. The Implementing department had constructed galleries with a combined length of about 144meters and a length of approximately 176m was still pending. The galleries adjacent to the rostrum had been constructed, fixing of truss and CGI Sheet Roofing had been done; sitting area inside the galleries, erecting of columns and plastering works had been done. Finishing works such as painting works was still pending. The galleries opposite to the rostrum were still under construction and it was found that the excavation works, laying of footing, erecting of wall in all four sides of the galleries had been done. Erecting of reinforcements for columns and fill of earth for sitting area were in progress.

View of Gallery under construction

- The Implementing department should complete the project as per specification mentioned in approved DPR.
- As already observed, a number of works are still pending and the major one is the RCC covered gallery (55% of the work is remaining). The implementing agency should ensure speedy completion within the overall sanctioned amount. If the UC's, progress report and other document submitted by the State Government are in order, the concerned Sector should take a call on expediting fund release since the project is already more the 3 years old.

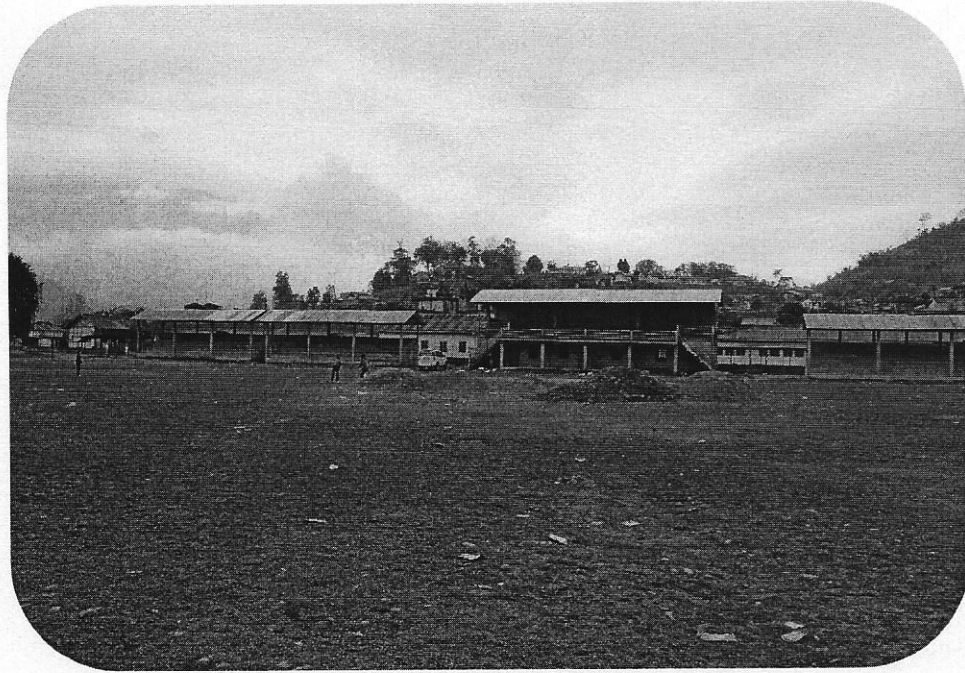
- It could be seen that the field had been developed and the Implementing department assured that the development of field had been done. It was found that the field was being used by the public and many children's were seen play in the field.

view of play ground, galleries and rostrum

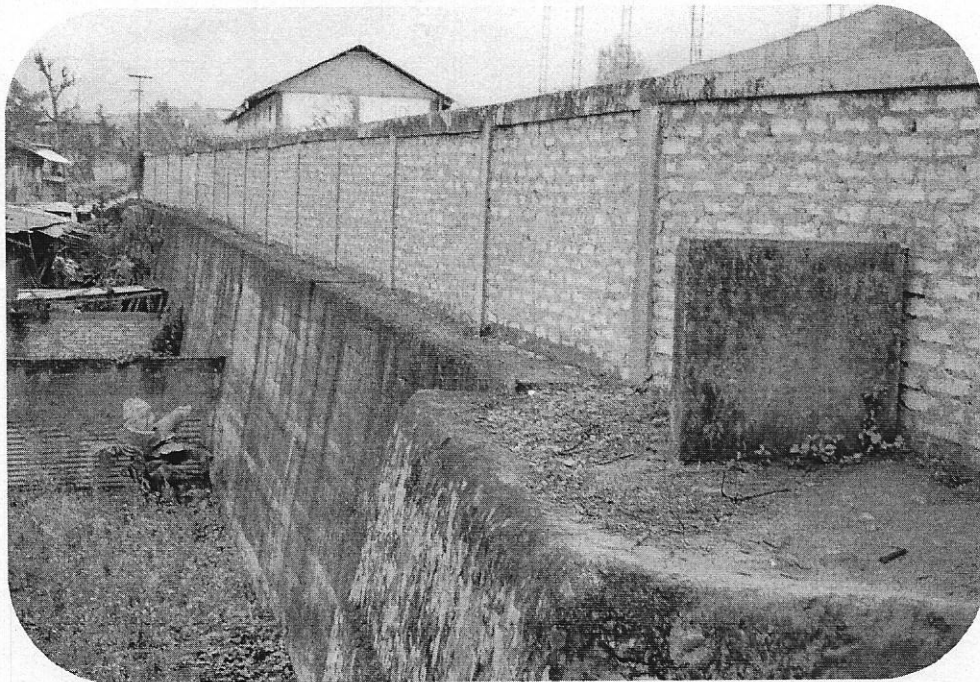
- The retaining wall had been constructed. The consultant had measured the height of the retaining wall and it was found to be approximately 3.5 m more or less above ground level. The Implementing department informed that the height of the wall varies due to site condition and they also informed that in some portion the height goes upto 4 metres. As per approved DPR, a random rubble masonry retaining wall was supposed to be constructed but the Implementing department had constructed a RCC retaining wall because to the site condition. Photographs of the retaining wall during the construction process are also attached.

- The VIP Gallery had been constructed and its plinth area at site was found to be approximately 25x7.5 meters.
- The additional works done by the Executing agency which was required due to site conditioned were construction of RCC retaining wall instead of RR retaining wall, construction of boundary wall with a length of approximately 150m i.e. as informed by the Implementing department.

View of RCC retaining wall and boundary wall after construction

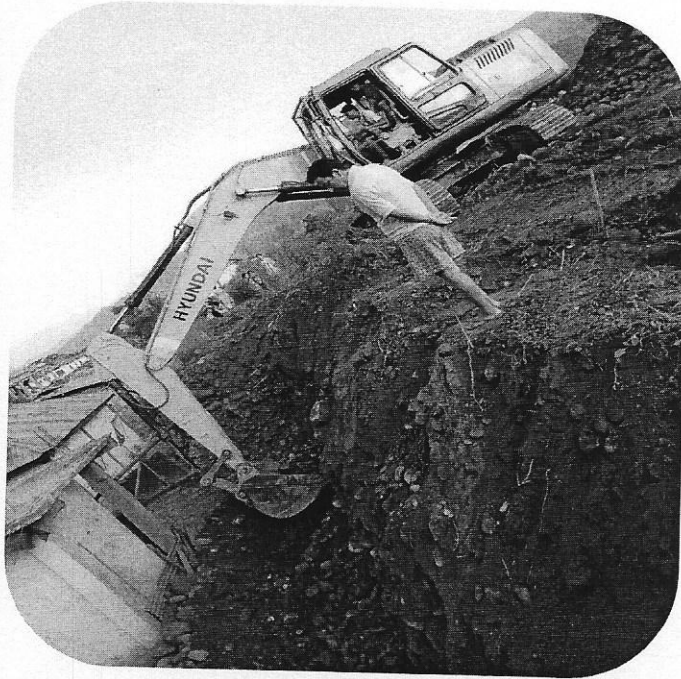
View of excavation done for retaining wall

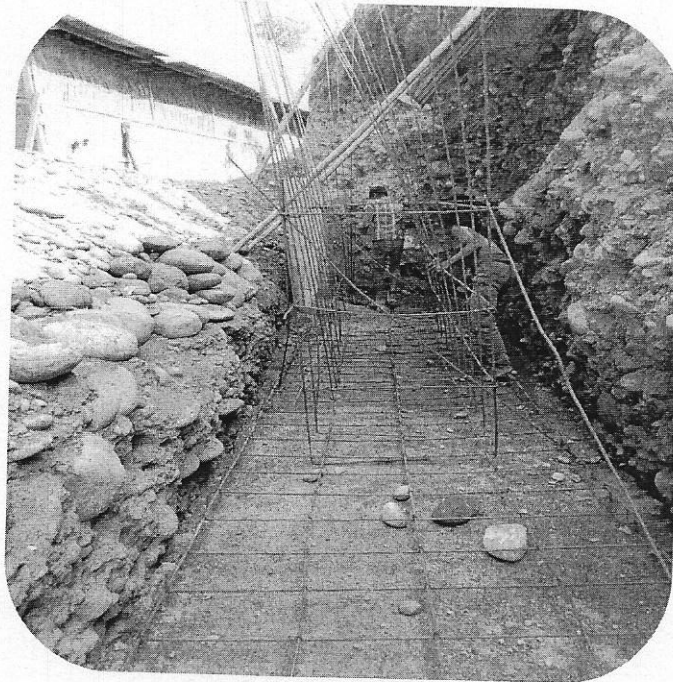
Laying of reinforcement for RCC retaining wall

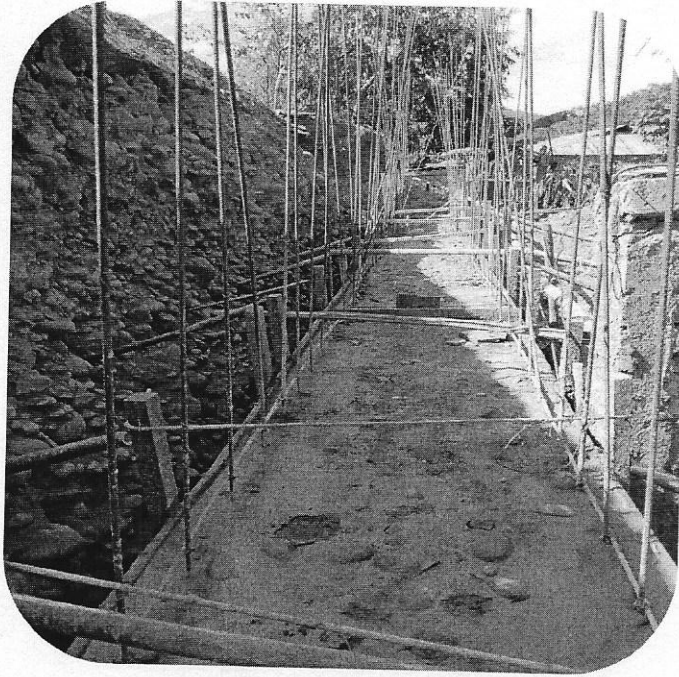
Laying of concrete for retaining wall

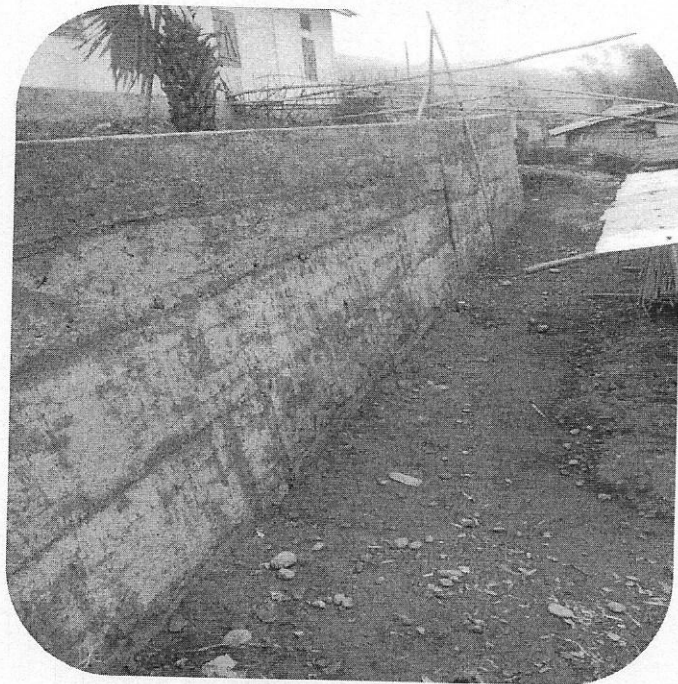
5.	Uncovered drain inside. 205.	3,63,055	Work not yet Started.
6.	Retaining Wall. 2m height and length 200 mtrs.	10,86,896	<ul style="list-style-type: none"> <li>• During inspection it was found that the wall had been constructed. The consultant had measured the height of the retaining wall and it was found to be approximately 3.5 m more or less above ground level. The Implementing department informed that the height of the wall varies due to site condition and they also informed that in some portion the height goes upto 4metres.</li> <li>• As per approved DPR, a random rubble masonry retaining wall was supposed to be constructed but the Implementing department had constructed a RCC retaining wall due to the site condition.</li> <li>• Photographs of the retaining wall during the construction process are also attached.</li> <li>• The consultant could not measure the length of the wall because the area was covered in vegetation but the implementing agency informed that the length of the retaining wall was around 120meters.</li> </ul>

view of completed wall
