GOVERNMENT OF INDIA  
NORTH EASTERN COUNCIL SECRETARIAT  
NONGRIM HILLS, SHILLONG - 793003

**Subject: Forwarding of Inspection Report.**

**Report of the inspection carried on 07/02/2017, 8/02/2017 & 9/02/2017 for the NEC funded project "Setting-up of a Seed Testing Laboratory in Meghalaya".**

Name of the project:	"Setting- up of a Seed Testing Laboratory in Meghalaya"
Location:	Meghalaya
Implementing Agency:	Department of Agriculture, Govt. of Meghalaya.
Date of Sanction:	23/03/2013
Cost of Project:	Rs.575.42 lakhs
NEC Share (90%):	Rs.517.88 lakhs
State Share (10%):	Rs. 57.54 lakhs
NEC Share released & Dates:	1 <sup>st</sup> installment of Rs. 100.00 lakhs on 22/03/2013 2 <sup>nd</sup> installment of Rs. 310.72 lakhs on 20/05/2014
Total Amount Released:	Rs. 410.72 lakhs
Balance amount to be released by NEC:	Rs. 107.16 lakhs
State Share released :	Rs. 11.11 lakhs
Balance amount to be released by State:	Rs. 46.43 lakhs
Status of UC for NEC share :	UC for Rs.100.00 lakhs for 1 <sup>st</sup> installment submitted on 12/03/2014 UC for Rs.310.72 lakhs for 2 <sup>nd</sup> installment Submitted on 16/12/2016
Status of UC for State share :	UC for Rs 11.11 lakhs for 1 <sup>st</sup> instal

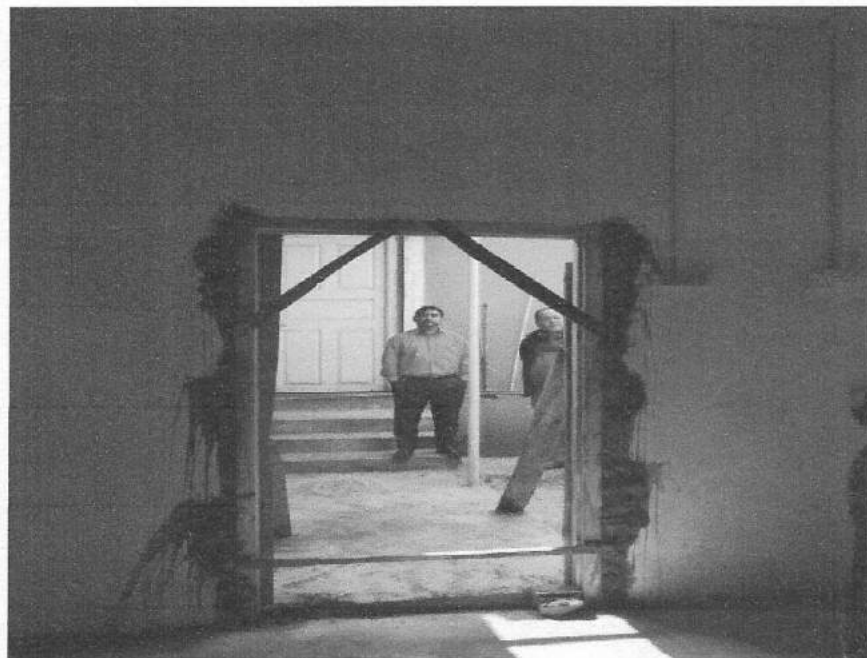
View of entrance to the Labrotary and renovation of the door

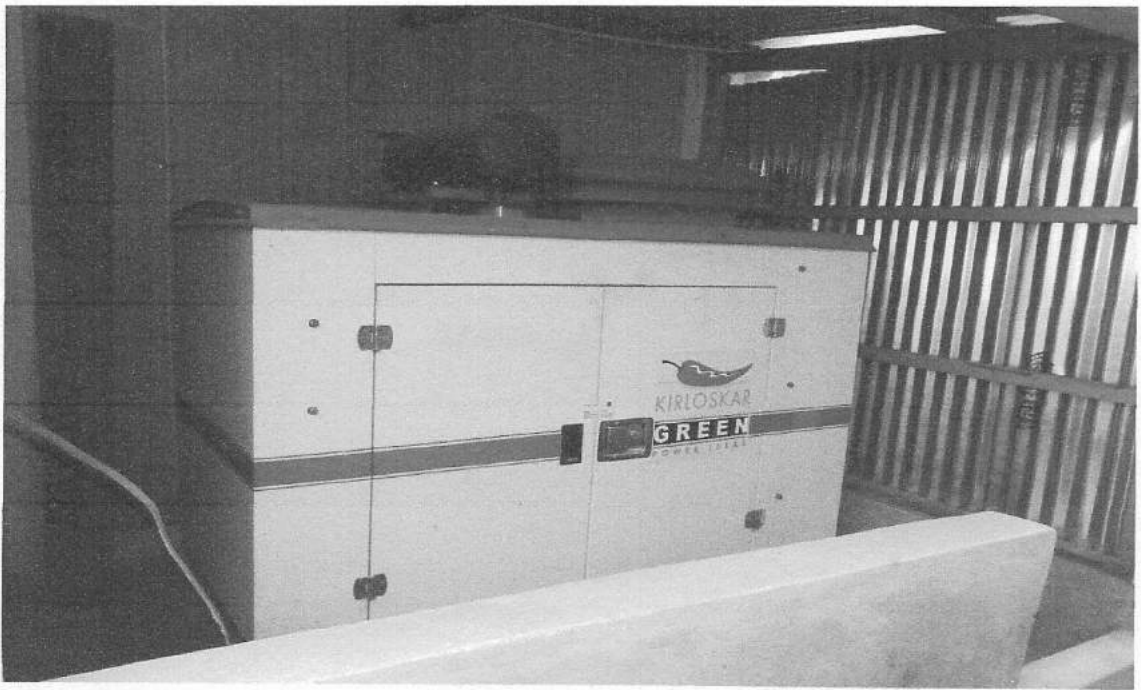
In Shillong, it was found that Implementing agency had constructed the Seed Health Test Room. The plinth area found was 6.5m.x4.65m. The painting work inside the building is still pending including wood works. The inspection team found that the entrance door was not yet fitted. Electrical wiring was found completed but implementing agency has not fitted the exhaust pipe for the generator and had installed one no. of earthing for the Generator.

View of the Generator

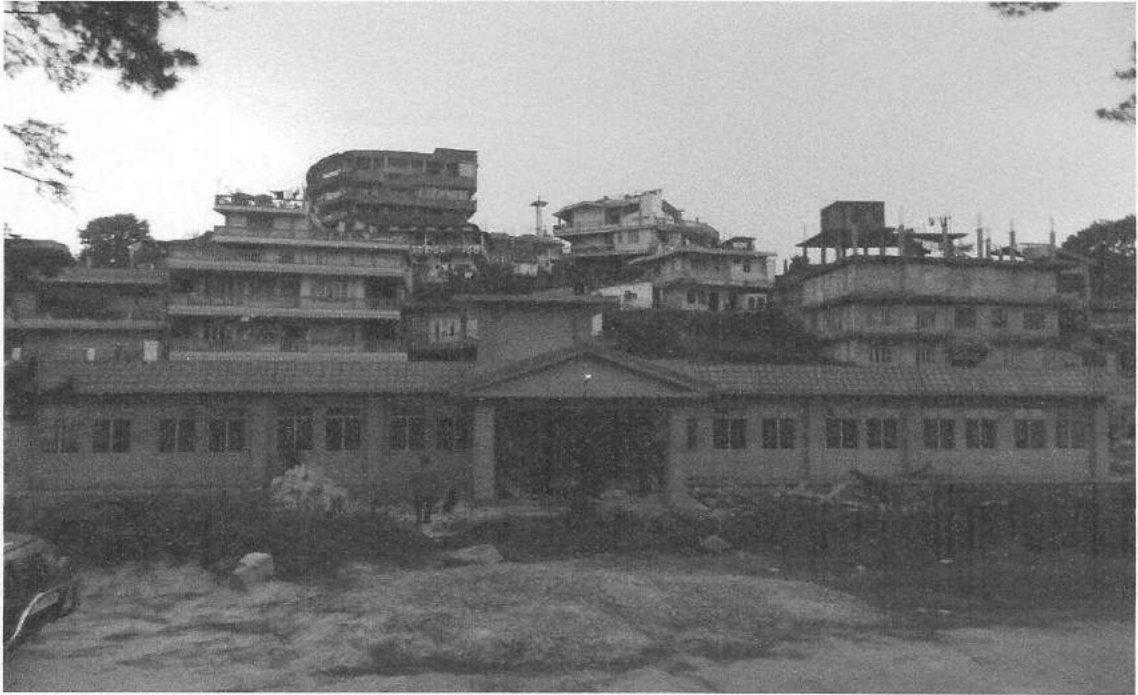
On inspecting the Seed Health Test Room at Jowai, Jaintia Hills, the following observations were made. The plinth area was found 30.56m.x 12.54m. The marble fitting works at the entrance lobby, passage and stair case have not started. Glazed ceramic Tiles are yet to be fitted in the ADA's Toilet, Ladies Toilet and Gent's Toilet. Plaster of Paris Putty, Plastic emulsion paint, weather shield acrylic exterior painting works have not started. Electrical

A front view of the Seed Testing Laboratory at Jowai, Jaintia Hills.

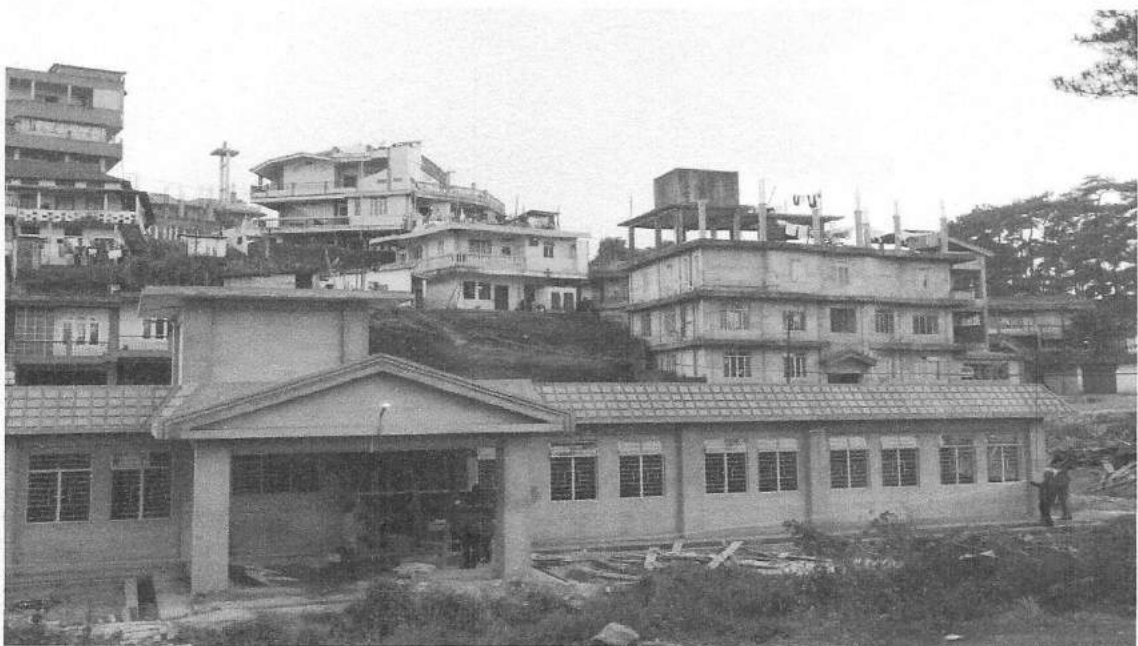
A view of the Inspection Team measuring the Plinth Area of the Laboratory.

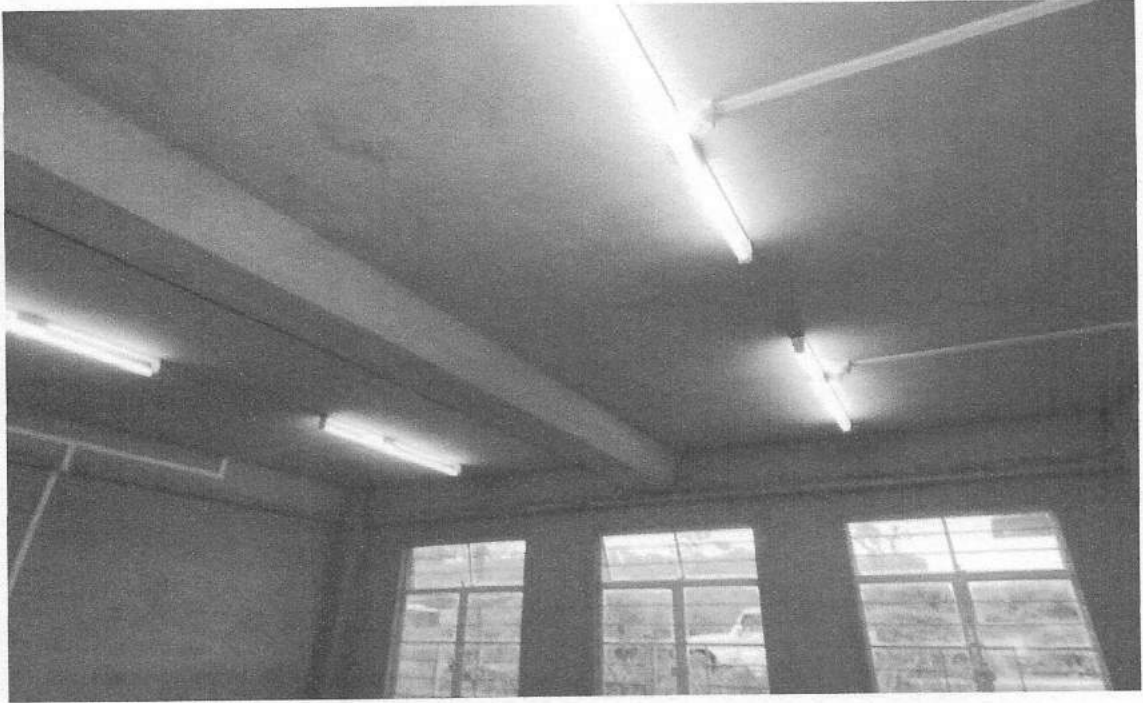
works were incomplete and proper earthing for the entire building was not done properly. The earthing should have earthing chamber with covering slab, test joint and earthing strip.

A view of the interior of a room along with the electrical work.

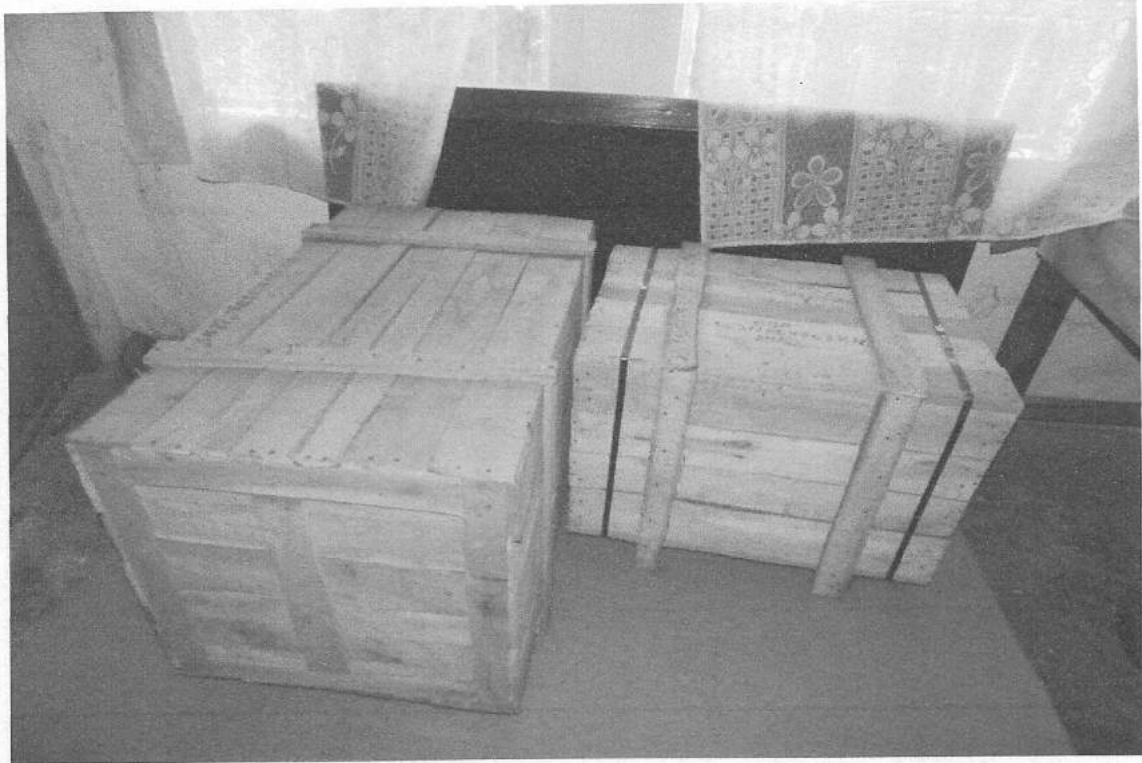
<ul style="list-style-type: none"> <li>• Seed Blower 1no.</li> </ul>	During Inspection it was found that Implementing agency had procured the material but it hasn't been installed and commissioned.
		<ul style="list-style-type: none"> <li>• Seed Germinator (double chamber) 1no.</li> </ul>	Not found.
		<ul style="list-style-type: none"> <li>• Counting Board 1no.</li> </ul>	During Inspection it was found that Implementing agency had procured the material but it hasn't been installed and commissioned.
		<ul style="list-style-type: none"> <li>• Moisture Meter 1 no.</li> </ul>	During Inspection it was found that Implementing agency had procured the material but it hasn't been installed and commissioned.
		<ul style="list-style-type: none"> <li>• Purity work Board 1no.</li> </ul>	During Inspection it was found that Implementing agency had procured the material but it hasn't been installed and commissioned.

A view of the Seed Blower

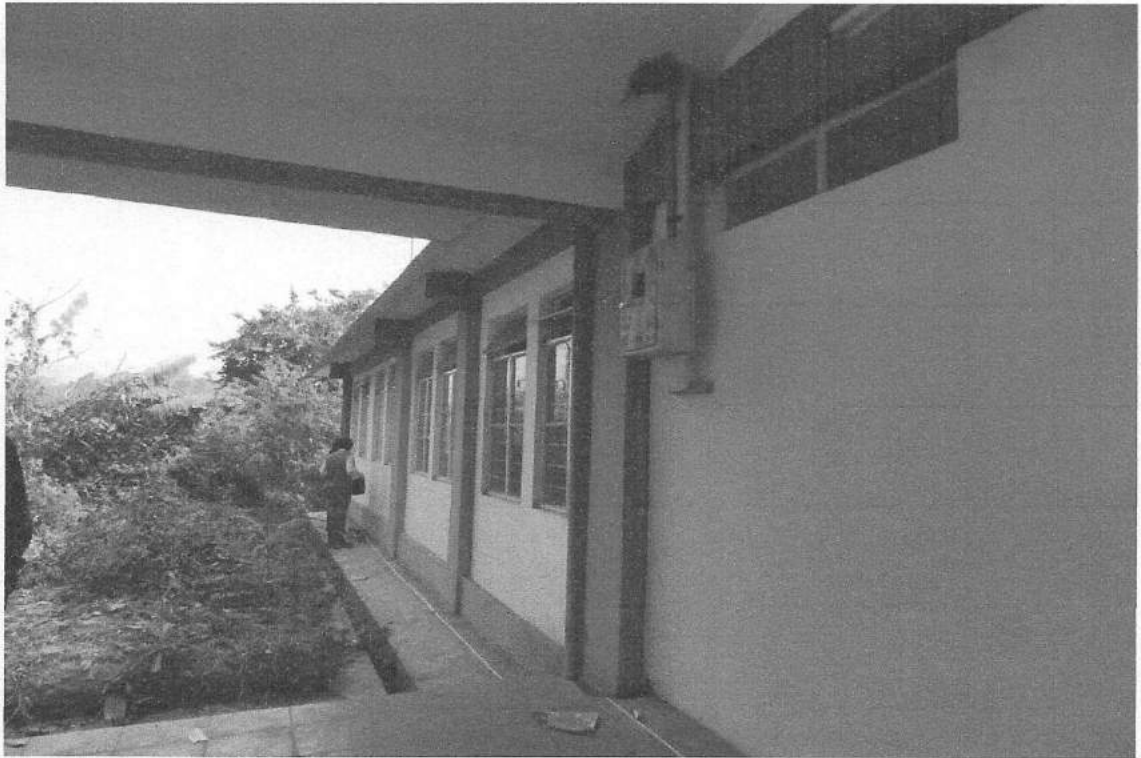
At Nongpoh, Ri Bhoi District, many anomalies were found, the plinth area found was 27.6m.x 12.9m which differs from the actual plinth area i.e. 30.5m x 12.5m. It was seen that the Implementing Agency used red oxide pigment on the staircase but in the approved D.P.R. Item no.26/4.25 Marble stone flooring over 20mm (average) was estimated. Inspection team also found that the Implementing Agency used tiles for the flooring of the entrance lobby and passage but in the approved D.P.R. Item no.26/4.25 Marble stone flooring over 20mm (average) was estimated. Moreover it was found that Toilet doors were all wooden but in the approved D.P.R. Item no.18/18.6 and 20/18.4 P.V.C Chowkhat and Solid P.V.C Door was estimated. Apart from this, the Inspection team noticed that the doors to the other rooms were of cardboard-type but in the approved D.P.R. Item no.19/7.13, 38 mm thick full paneled shutter door made of Red pine Wood/local wood was estimated. The workmanship for the gents and ladies Toilet were not properly constructed .Many Cracks were found in the building. The Inspection Team found that electrical works and painting of the building were completed but through visual inspection it seemed that the implementing agency did not apply Paris of Putty of 2 mm thickness over plastered surface to smooth out the surface as was estimated in the approved DPR Item No. 29/4.62.

A view of the inspection taking the Plinth Area.

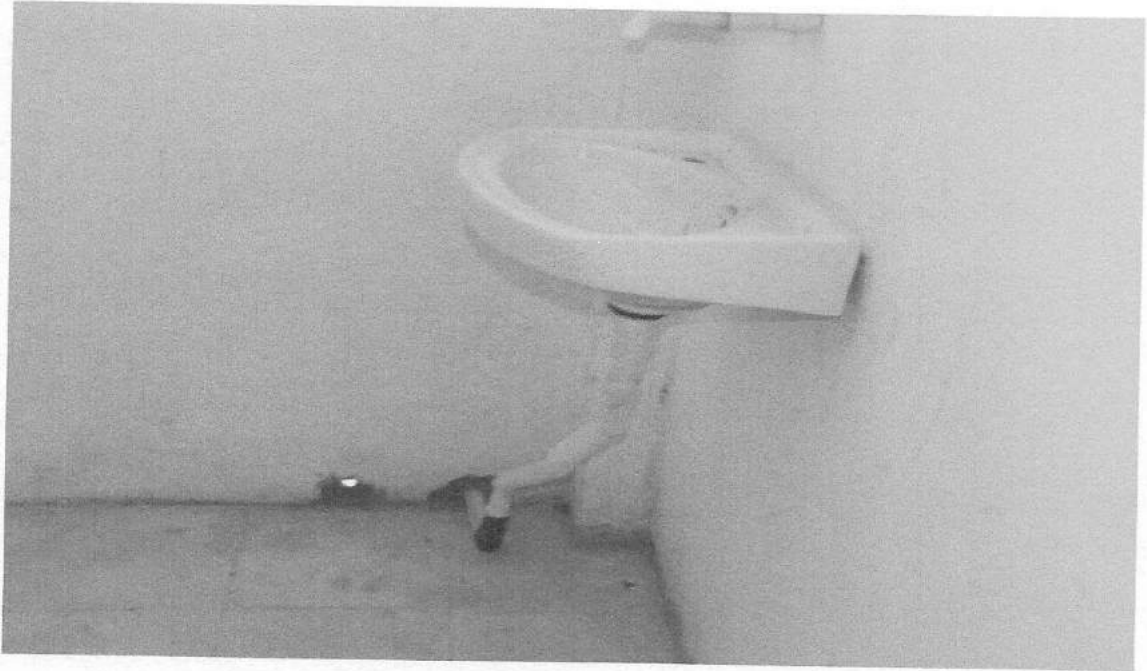
A view of the sink without proper tap .

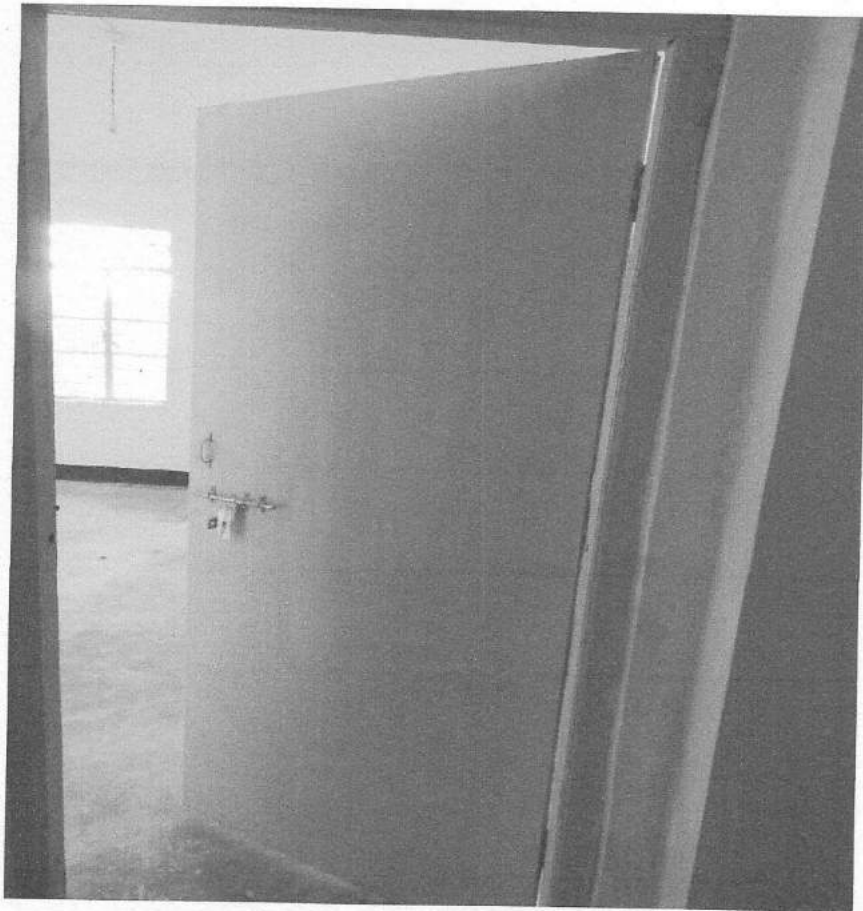
A view of the door where plywood is being used.

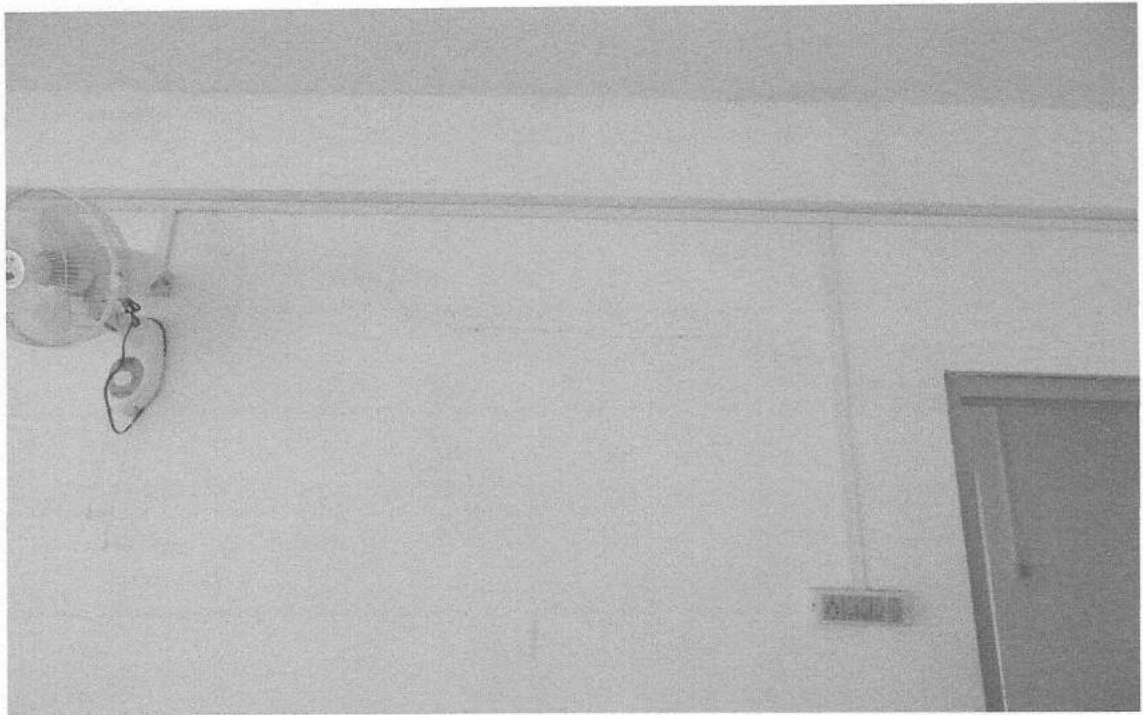
3.	Nongpoh, Ri-Bhoi District.	<ul style="list-style-type: none"> <li>• Construction of Seed Testing Laboratory. 30.5 mx12.5m (Plinth area from approved drawing)</li> </ul>	<p>During Inspection it was found that the Implementing Agency has constructed the Seed Health Test Room at Nongpoh, Ri-Bhoi District but the plinth area found was 27.6m.x 12.9m. It was observed that the Implementing Agency used 'red oxide pigment' on the staircase but in the approved D.P.R. Item no.26/4.25 Marble stone flooring over 20mm (average) was estimated. Inspection team found that the Implementing agency finished the flooring of entrance lobby and passage but they have used Tiles instead of marble as approved in the D.P.R, i.e, Item no.26/4.25 Marble-stone flooring over 20mm(average) was estimated.</p> <p>Moreover it was also found that the Toilet doors were all wooden but in the approved D.P.R. Item no.18/18.6 and 20/18.4 P.V.C Chowkhat and Solid P.V.C Door was estimated. Inspection team noticed that cardboard-type doors were fixed to the rooms, but in the approved D.P.R. Item no.19/7/13, 38 mm thick full paneled shutter door made by Red pine Wood/local wood was estimated. Inspection team also found that the workmanship of the Gents and Ladies toilet was not done properly.</p> <p>During inspection it was found that the electrical works and painting of the building was completed but by visual inspection it seemed that the Implementing Agency did not use 'Paris of Putty' of 2 mm thickness over plastered surface to prepare the surface evenly smooth as it is estimated in the approved DPR Item No. 29/4.62. Cracks were found on the wall of the Laboratory.</p>

A view of the crack on the wall found inside the building

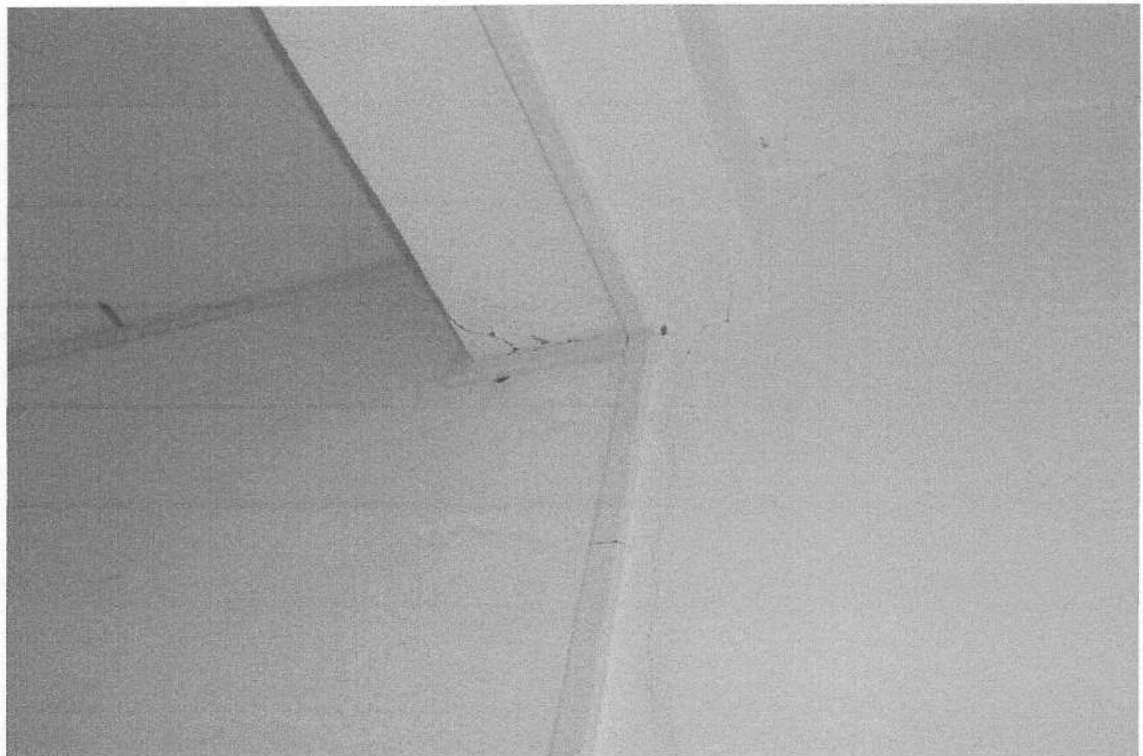
A view of the crack on the wall found inside the building

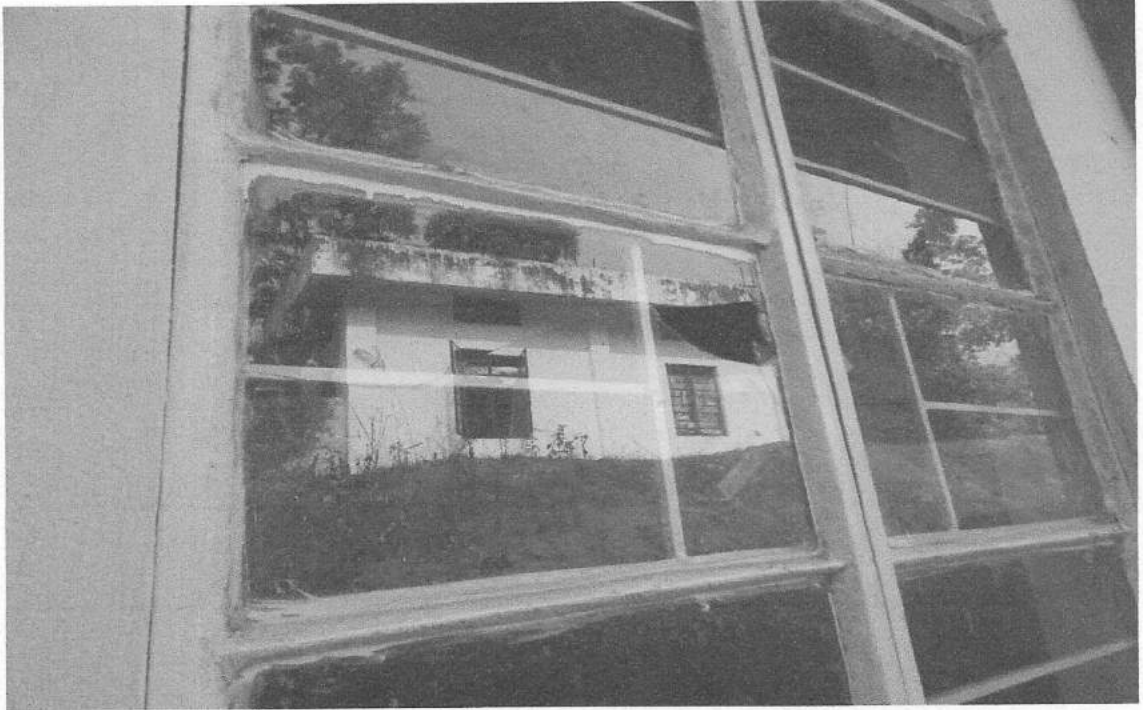
A view of the broken glass on the window.

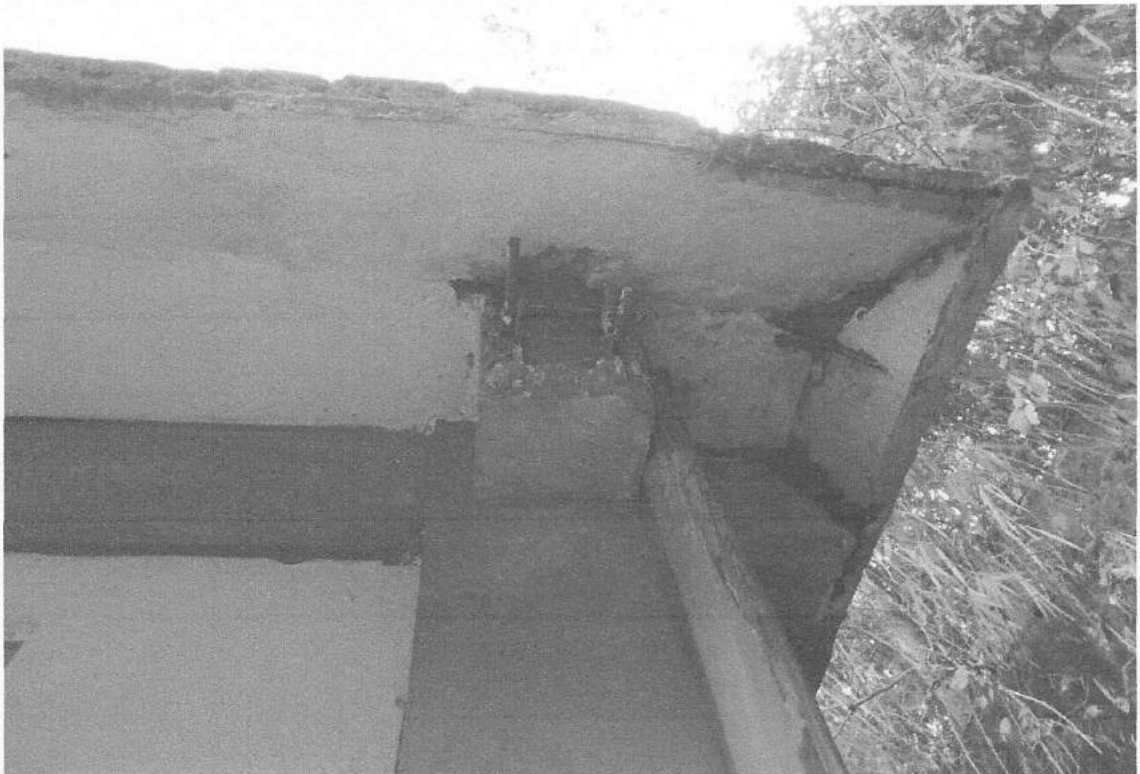
A view of cracks found on the exterior wall.

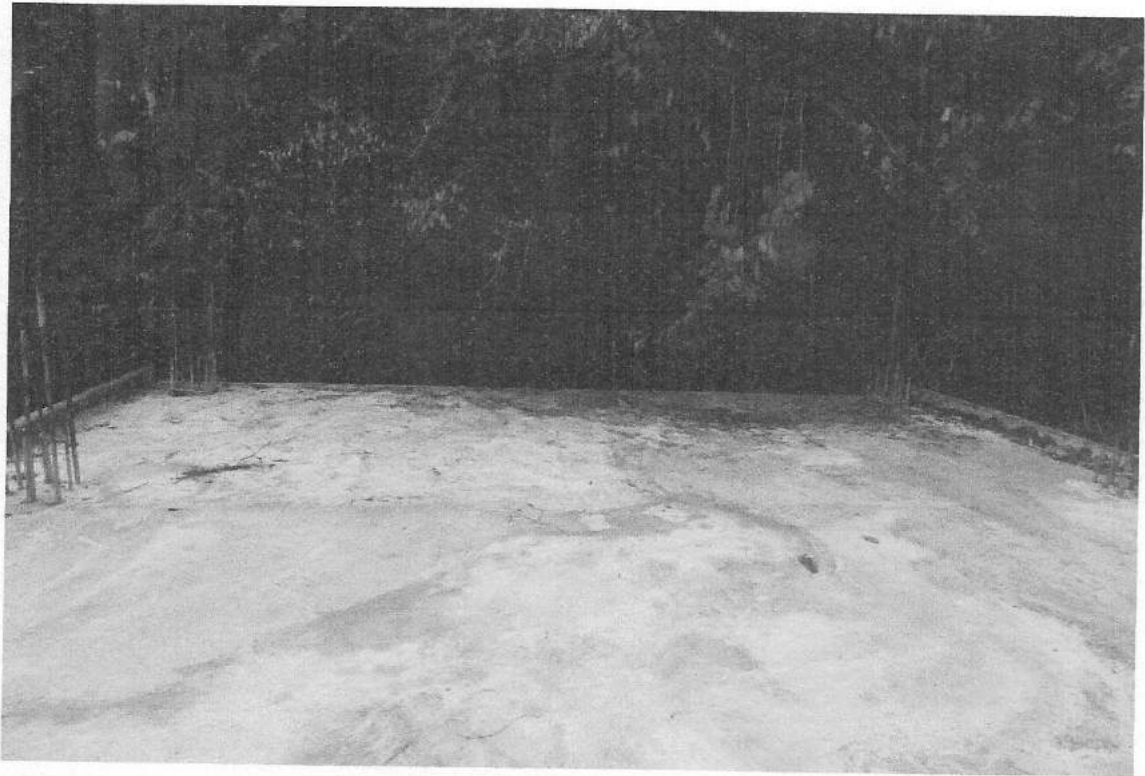
No roof protection found.

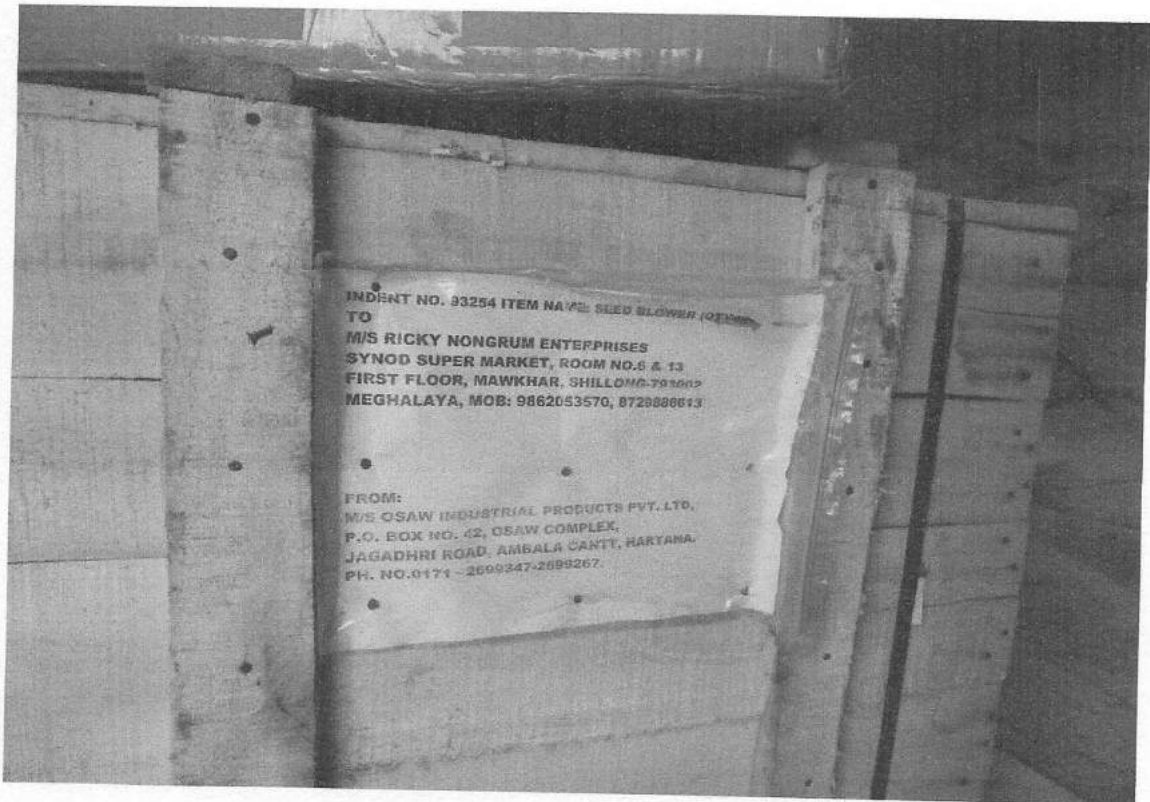
<ul style="list-style-type: none"> <li>Seed Blower 1no.</li> </ul>	During Inspection it was found that Implementing agency had procured the material but it hasn't been installed and commissioned.
	<ul style="list-style-type: none"> <li>Seed Germinator (double chamber) 1no.</li> </ul>	Not found.
	<ul style="list-style-type: none"> <li>Counting Board 1no.</li> </ul>	During Inspection it was found that Implementing agency had procured the material but it hasn't been installed and commissioned.
	<ul style="list-style-type: none"> <li>Moisture Meter 1 no.</li> </ul>	During Inspection it was found that Implementing agency had procured the material but it hasn't been installed and commissioned.
	<ul style="list-style-type: none"> <li>Purity work Board 1no.</li> </ul>	During Inspection it was found that Implementing agency had procured the material but it hasn't been installed and commissioned.
	<ul style="list-style-type: none"> <li>Seed Counter Computerise 1 no.</li> </ul>	During Inspection it was found that Implementing agency had procured the material but it hasn't been installed and commissioned.

A picture of the Seed Blower.

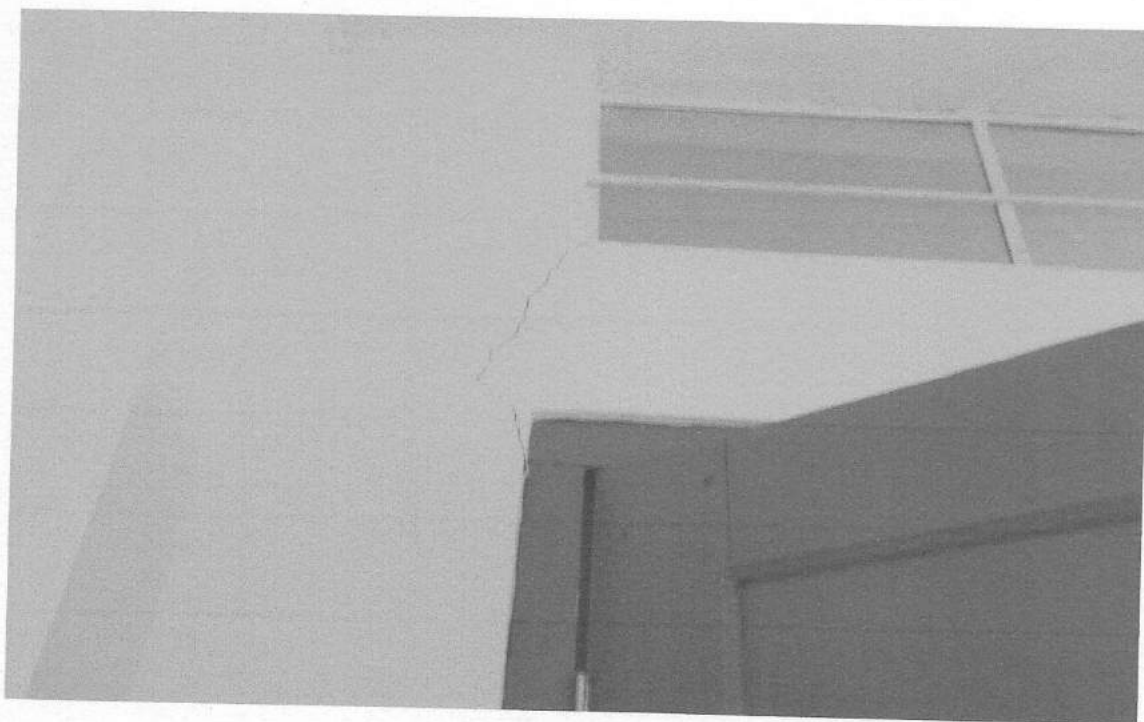
A view of the cracks found in the interior wall.

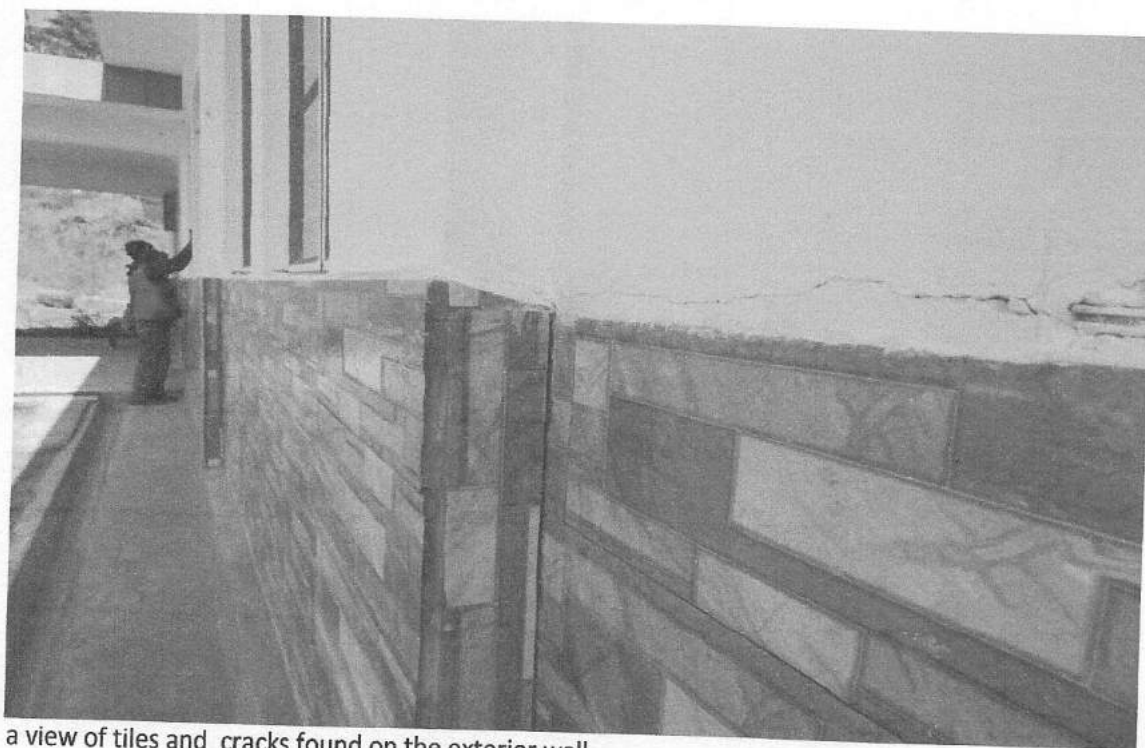
a view of tiles and cracks found on the exterior wall.

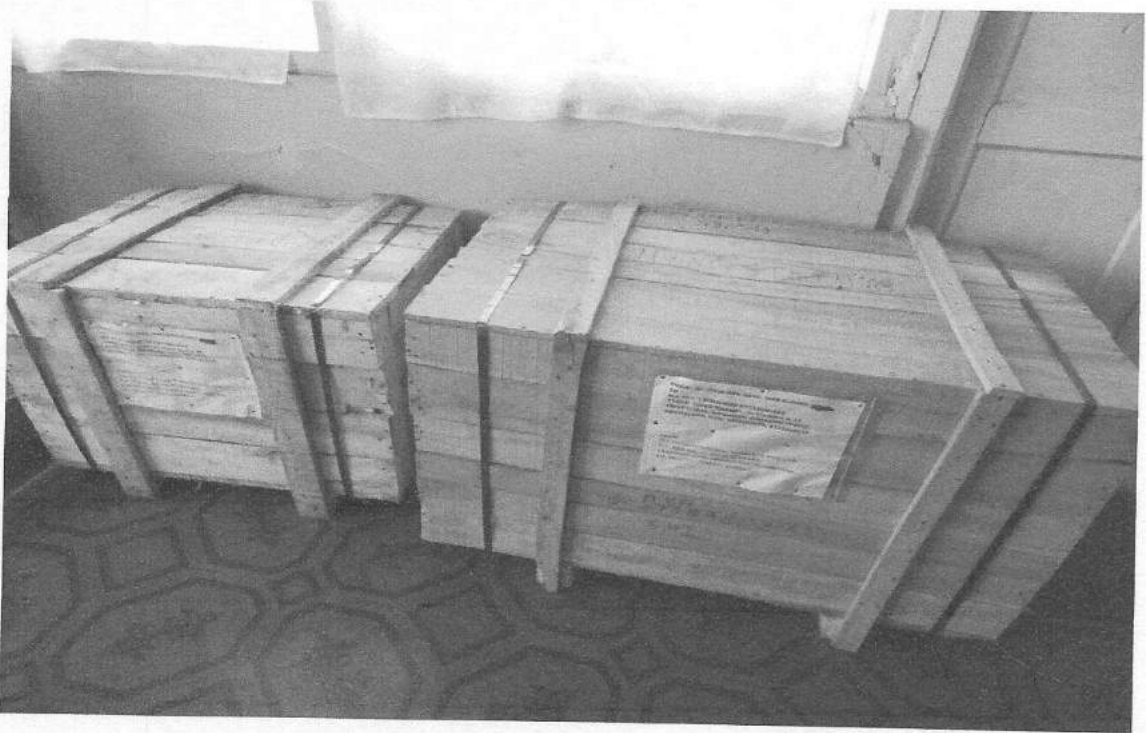
was suggested to do proper plate earthing for the smooth running of the sophisticated instruments which would be installed.
		<ul style="list-style-type: none"> <li>Seed Blower 1no.</li> </ul>	During Inspection it was found that the Implementing agency had procured the material but it hasn't been installed and commissioned.
		<ul style="list-style-type: none"> <li>Seed Germinator (double chamber) 1 no.</li> </ul>	Not found.
		<ul style="list-style-type: none"> <li>Counting Board 1 no.</li> </ul>	During Inspection it was found that Implementing agency had procured the material but it hasn't been installed and commissioned.
		<ul style="list-style-type: none"> <li>Moisture Meter 1 no.</li> </ul>	During Inspection it was found that Implementing agency had procured the material but it hasn't been installed and commissioned.
		<ul style="list-style-type: none"> <li>Purity Work Board 1 no.</li> </ul>	During Inspection it was found that Implementing agency had procured the material but it hasn't been installed and commissioned.

A view of the box which contains the Seed Blower.
