Subject: Forwarding of Inspection Report.

Report of the inspection carried on 12/01/2018 for the NEC funded project "Construction of Multipurpose Indoor Stadium at Garobadha, South West Garo Hills District, Meghalaya."

Name of the project:	Construction of Multipurpose Indoor Stadium at Garobadha, South West Garo Hills District, Meghalaya.
Location	South West Garo, Meghalaya.
Implementing Agency:	Director, Sports and Youth Affairs Department.
Date of Sanction:	5/03/2014
Cost of Project:	Rs. 748.96 lakhs
NEC Share	Rs. 674.06 lakhs
State Share	Rs. 74.90 lakhs
NEC Share released & Dates	1 st installment of Rs. 269.60lakhs released on 5/03/2014
Total Amount Released By NEC:	Rs. 269.60 Lakhs
Total Amount Released By State Share:	Rs. 74.90 lakhs
Balance amount to be released by NEC	Rs. 404.46 Lakhs
Balance amount to be released by State Share	Nil
Status of UC for 1 st installment	Not yet submitted
Target Date of Completion	2 years
Time Overrun	22 months.

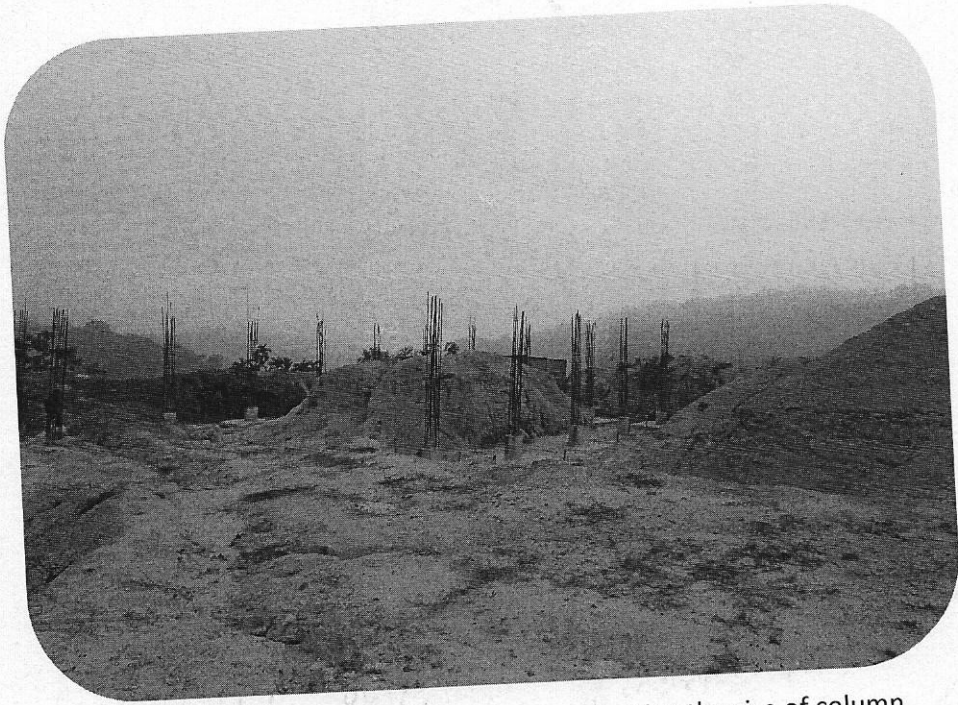
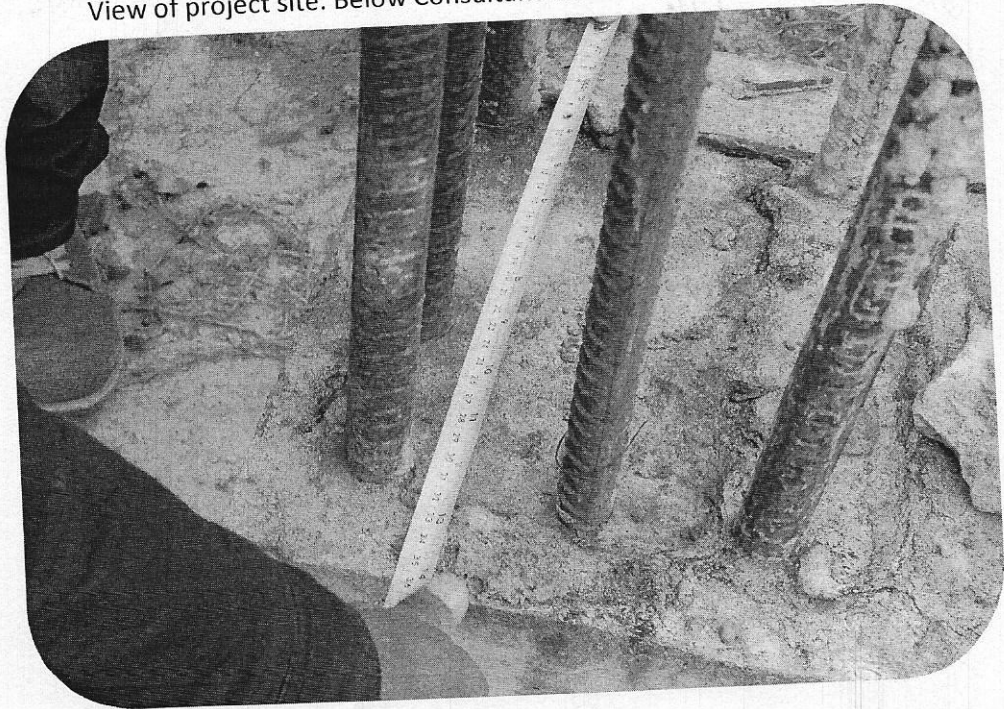
Sl.No.	Scope of Work as per DPR		Remark
1.	Ground floor (3100 sqm)	5,54,90,000	<ul style="list-style-type: none">• During inspection it was found that the construction works had been halted. The Implementing Department informed that the works had been halted since March 2017 because no payment was made to the executing agency. The Implementing department informed that "during the construction process i.e. somewhere in 2015-2016, it was found that the structural foundation in the approved DPR was not safe for the construction of Multipurpose Indoor Stadium because the soil condition at site was very loose, therefore soil test had been conducted and it was found that the safe bearing capacity of the soil at 3m below the ground level was only 8 tons and the safe bearing capacity of the soil at 13m below ground level was 21 tons. So in this case in order to lay the foundation of the Multipurpose Indoor Stadium in a hard and safe soil i.e. at a depth of about 13m below ground level, pile foundation had been adopted". The Implementing department also informed that a minimum of 4 pile foundations was required for one footing which was very expensive and due to this pile works, the price for construction has shot up tremendously. The Inspection team has also taken photographs of the pile works done at site. Till date piling had been done for Block A & one part of Block B i.e. left block & right hand side middle block respectively.• The concerned sector should take a call on this matter regarding providing pile foundation taking into consideration the safety of the Multipurpose Indoor Stadium.• It was found that the size of all the columns provide at site were 350 x 500mm. As per approved DPR, the columns sizes were suppose to be 300x300mm for 24 nos. of columns, 350x500mm for 24 nos. of columns and 300x750mm for 2 nos. of columns. So technically from the size of the columns used at site, we could conclude that the amount of concrete used for columns at site was more than what was specified in approved DPR. The reinforcement used at site for the columns till date

were found to be more than what was specified in the approved DPR.
2	First floor (842sqm)	1,23,32,774	Not yet Started.
3	Sanitary and water supply	42,54,358.05	Not yet Started.
4	Internal Electrification	42,54,358.05	Not yet Started.
5	Campus Development including Landscaping, Fencing and drainage	14,18,119.35	Not yet Started.

View of project site. Below Consultant measuring the size of column

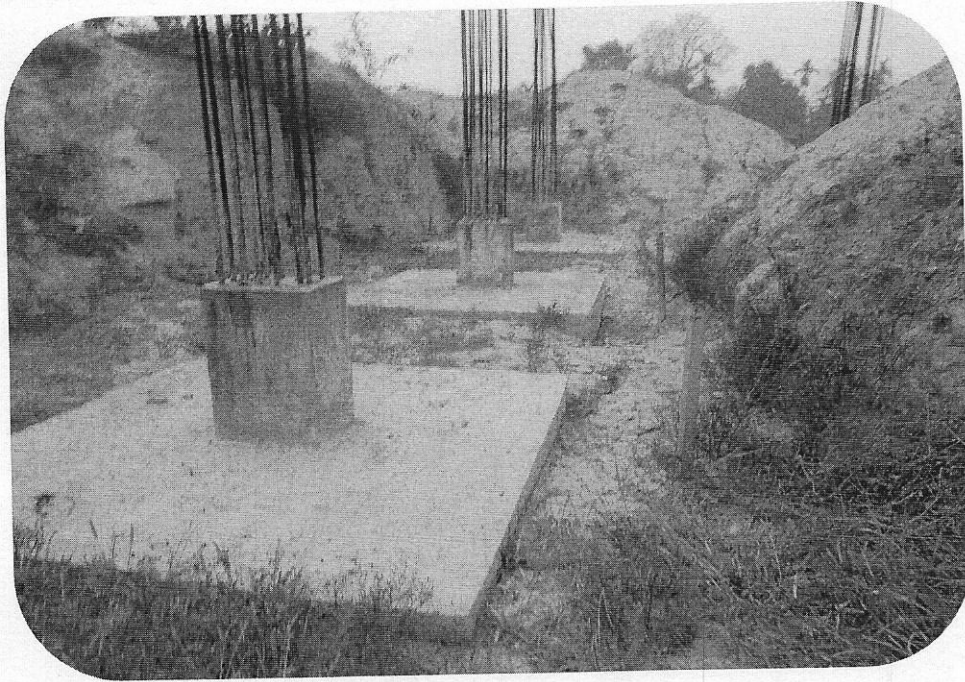
- In this case in order to lay the foundation of the Multipurpose Indoor Stadium in a hard and safe soil i.e. at a depth of about 13m below ground level, pile foundation had been adopted.

- A minimum of 4 pile foundations was required for one footing which was very expensive and due to this pile works, the price for construction has shot up tremendously.

View of columns and base of footing laid over pile foundation

- So the concerned sector should take a call on this matter regarding providing pile foundation taking into consideration the safety of the Multipurpose Indoor Stadium. It looks like the approved DPR may need drastic revision but however the concerned Sector should take a decision on this matter.

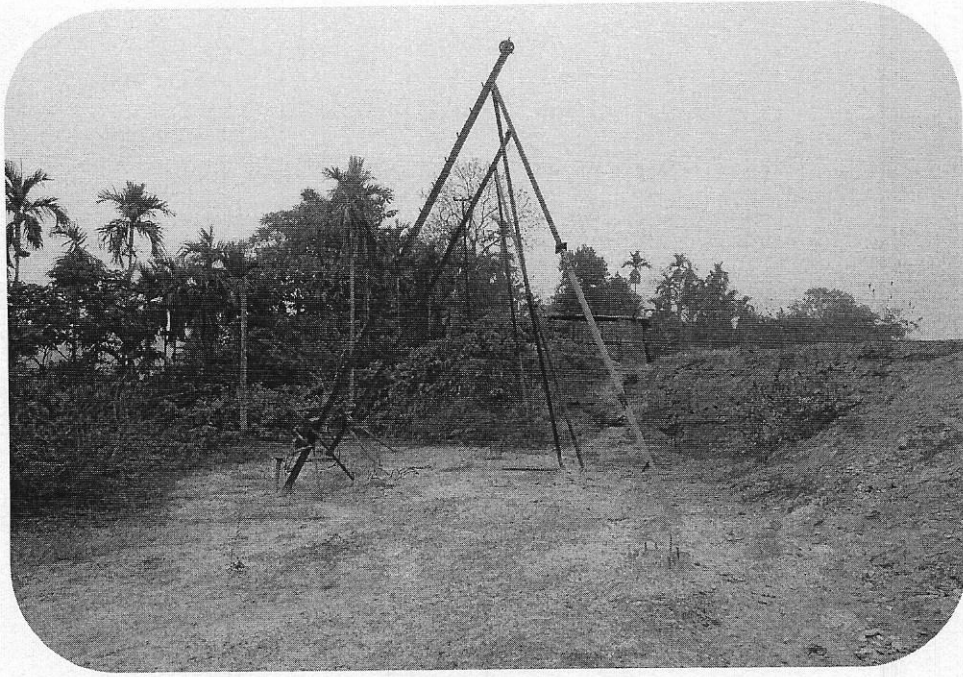
view of machine used for pile foundation.

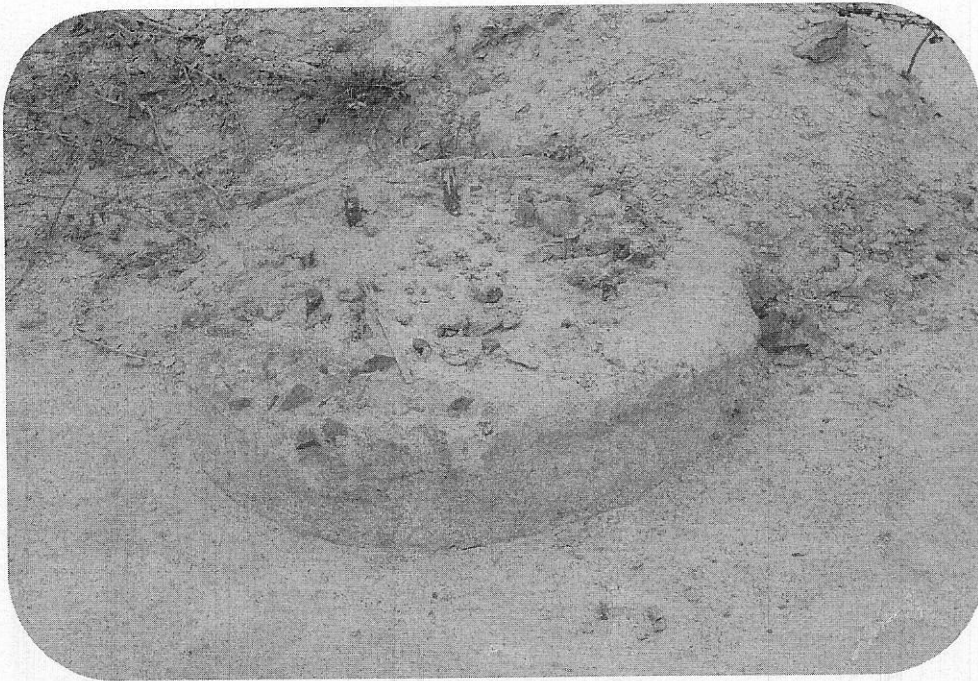
View of RCC works for pile foundation
