ect. Forwarding of Inspection Report.

## Report of the inspection carried out on 20/02/2018 for the NEC funded project "Construction of Outdoor Stadium at Tezu, Lohit District, Arunachal Pradesh".

Name of the project:	"Construction of Outdoor Stadium at Tezu, Lohit District, Arunachal Pradesh"			
Name of the project:	Tezu, Lohit District, Arunachal Pradesh			
Location	Department of Sport and youth Affair.			
Implementing Agency:				
Date of Sanction:	17 <sup>th</sup> December, 2014			
Cost of Project:	Rs. 221.15 lakhs			
NEC Share (90%):	Rs. 199.04 lakhs			
State Share (10%)	Rs. 22.11 lakhs			
Total Amount Released by NEC	Rs. 159.24 lakhs			
Balanced amount to be Released by NEC	Rs. 39.8 lakhs			
Total Amount Released by the State:	Rs. 22.11 lakhslakhs			
Balanced Amount to be released by the	nil			
State:	17/10/0014			
NEC Share released & Dates:	1 <sup>st</sup> installment of Rs. 79.62 lakhs released on 17/12/2014			
Tibe share research	2 <sup>nd</sup> installment of Rs. 79.62 lakhs released on 28 <sup>th</sup> July, 2017			
Status of UC for NEC share:	LIC of 1st installment of Rs79 62 lakhs submitted on 23/11/2016

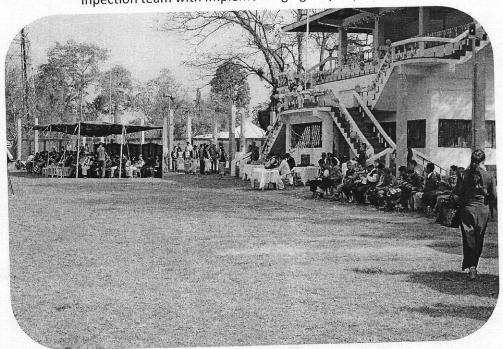
Function taking place at the project site.

• It was found during inspection that the ground was being used by the public for various functions. During the time of inspection, the ground was used by the State Government for Statehood day celebration.

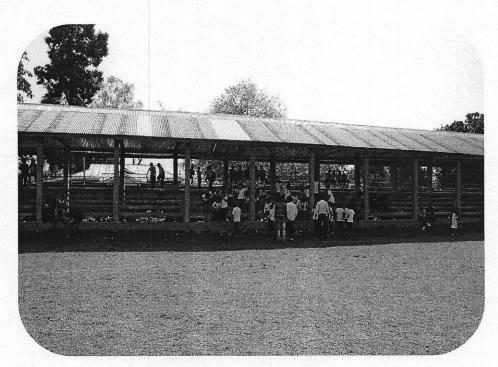
View of Gallery

- The Implementing department had constructed 2 nos. of covered galleries each having an area of approximately 54 x 6 mtrs i.e. as per approved DPR. It could be seen that the 3<sup>rd</sup> gallery was still under construction and erecting of columns had been done. The reinforcement used for the columns at site was 4 nos. of 16mm dia bars which was as per approved DPR.

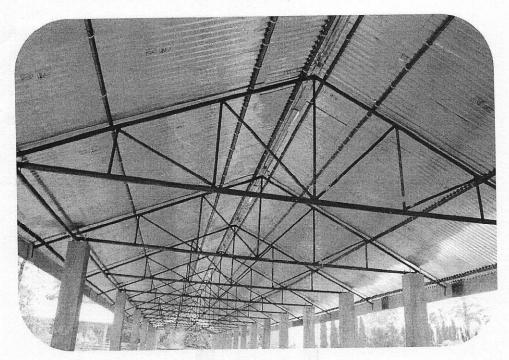
View of truss and GI sheet

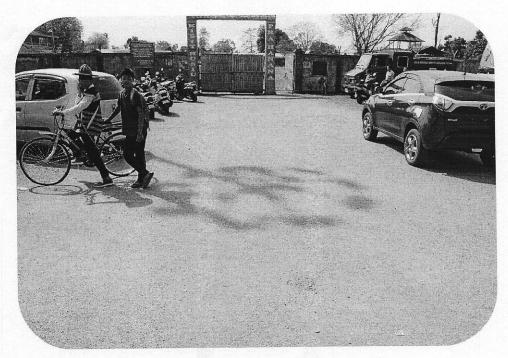
10	Approach road	17,43,531	It could be seen that only the approach road to the ground had been done. The Implementing department should complete the work as specification mentioned in approved DPR.
11	Cross drainage, RCC Slab culvert 1 mtr span.	18,71,972	Not yet started.

view of approach road

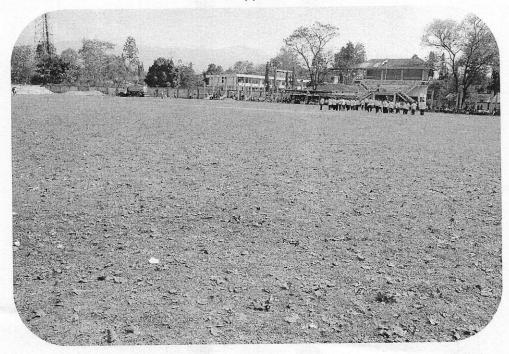
SI.	Scope of Work as per DPR	Approved	Observations & Remarks		
No.		cost of NEC			
		(in Rs.)			
1.	Raising and leveling of Ground	10,04,000	The Implementing Department informed that the raising and leveling of ground had been done and as per visual inspection it could be seen that the work has been done. Photograph enclosed.

2.	Planting carpet grass. 10,000sqm	2,48,900	The Implementing Department informed that the planting carpet grass had been done and as per visual inspection it could be seen that the work has been done. Photograph enclosed  During inspection it was found that the Implementing department had constructed 2 nos. of covered galleries each having an area of approximately 54 x 6 mtrs i.e. as per approved DPR. It could be seen that the 3 <sup>rd</sup> gallery was still under construction and erecting of columns had been done. The reinforcement used for the columns at site was 4 nos. of 16mm dia bars which was as per approved DPR.

View of play ground showing leveled field and planted grass.

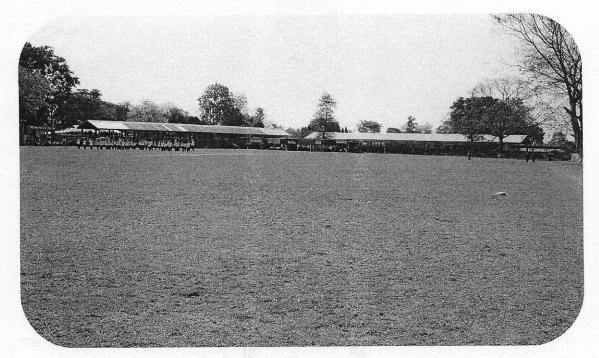
View of both galleries

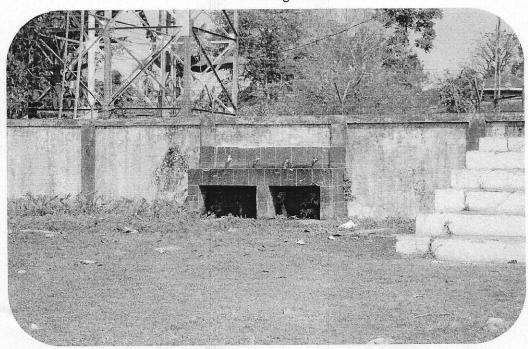
7.	Providing water supply arrangement	1,63,398	Work related to water supply has been done. Photographs enclosed.		
8.	Providing and fixing double leaf MS gate with RCC pillar	2,87,282	The Implementing department informed that the work had been completed since march 2015. was observed that the painting in the gate and in the pillars has worn out. Therefore the implementing department was instructed to repaint the gate and the pillars before submitting the completion report and photos should be send to NEC.

View of water tap installed

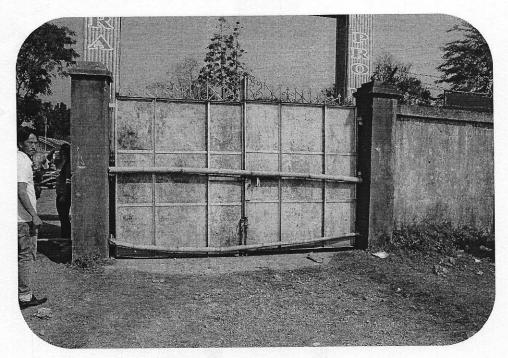
- As for the gate and pillar, the Implementing department informed that the work had been completed since march 2015. It was observed that the painting in the gate and in the pillars has worn out. Therefore the implementing department was instructed to repaint the gate and the pillars before submitting the completion report and photos should be send to NEC.

MS Gate

As for the gate and pillar, the Implementing department informed that the work had been completed since March 2015. It was observed that painting in the gate and in the pillars has worn out. Therefore the implementing department was instructed to repaint the gate and the pillars before submitting the

completion report and photos should be send to NEC

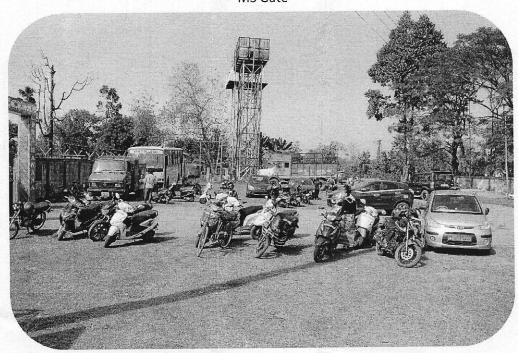
6.	Parking place.	11,96,637	It could be seen that filling of earth and leveling work has been done. It was also found durinspection that the parking place was being used by the public.

view of parking area
