GOVERNMENT OF INDIA NORTH EASTERN COUNCIL SECRETARIAT NONGRIM HILLS, SHILLONG – 793003

Subject: Forwarding of Inspection Report.

Report of the inspection carried on 09/08/2017 for the NEC funded project "Construction of Outdoor Stadium in Mon District, Nagaland."

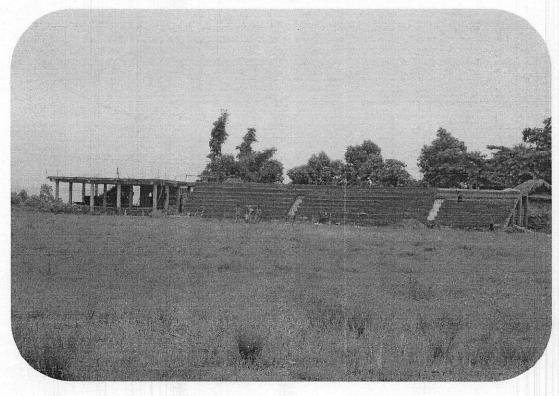
• For the Bays construction, it was found that the columns, beams and slab for the Bay B had been constructed. The length of the Bay was 33.9 m and as per DPR it was 33.4m.

• The Construction of the VIP rostrum was in progress. The Inspection team had measured the area of the rostrum and it was found to be approximately 108 sqm and as per DPR 126 sqm. Hence there was a difference of about 18 sqm. The Implementing department should construct the remaining 18 sqm.

View of Rostrum and gallery Bay B

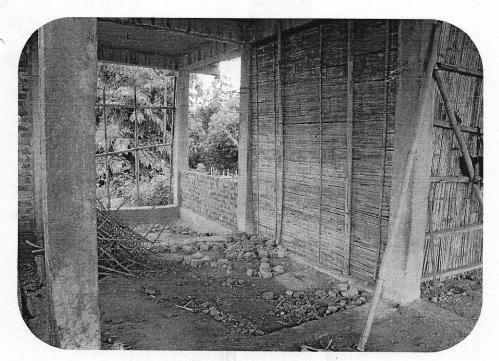
View of inside the Rostrum

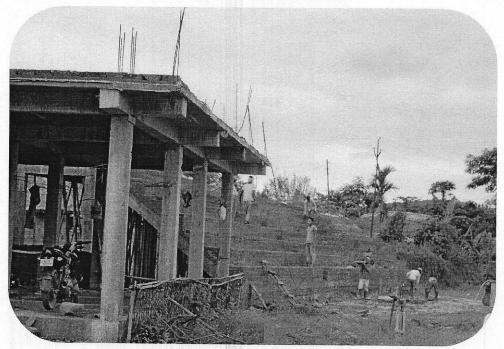
View of Project site

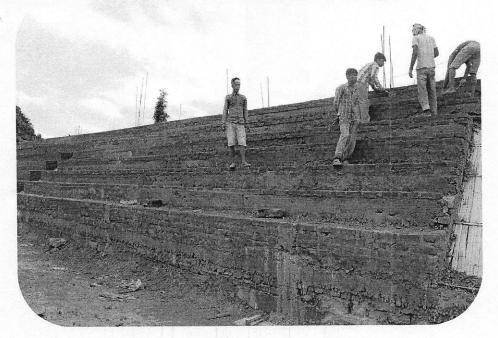
View of Gallery

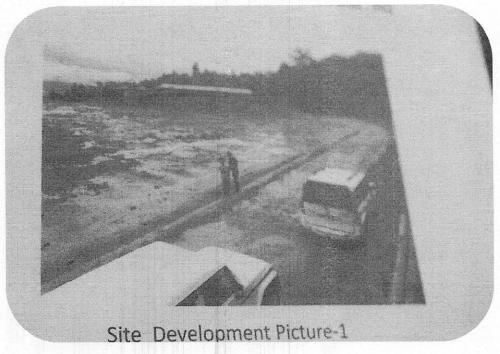
Photograph of land before the commencement of the project was also attached.

View of area before commencement of work

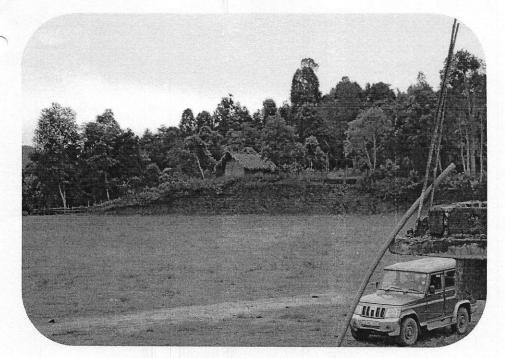
• The consultant had inspected the site and found that 95% of development of ground had been done.

View of area after excavation work

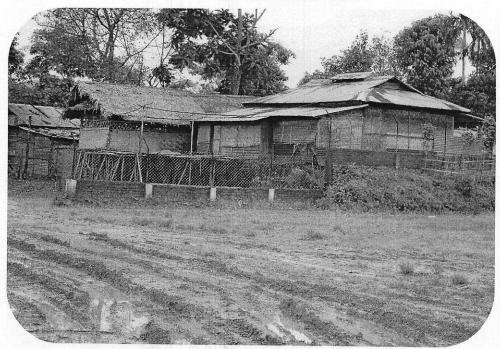
3.	Roof over gallery (Bay-B &D)2 bays	47,45,770.00	Implementing department should construct the remaining 18 sqm. The Work not yet started.
	Perimeter fencing (850m) including gate 2 nos.	18,59,448.00	It was found that the construction of perimeter fencing were in progress. The consultant had asked the labour to measure the length of the fencing and it was found to be 183.83 meters. 666.15 m was still.

View of boundary fencing

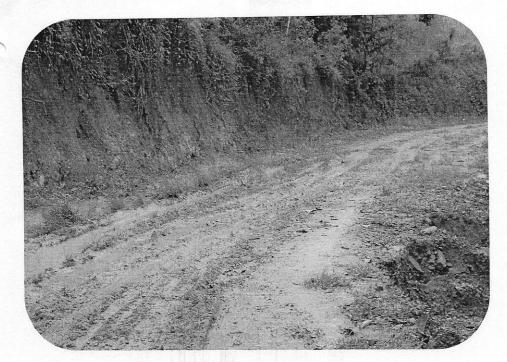
Excavation work for road construction had been done. The width of the excavated road was 8.2 meters. As per DRP the total width of the road including shoulder and drain was 5.2m. The total length excavated was approximately 785.74 meters. The construction of the retaining wall was found to be approximately 268.05m. The remaining length of 31.95 needs to be constructed at site. NEC funding was not found to be acknowledged.

View of excavated area

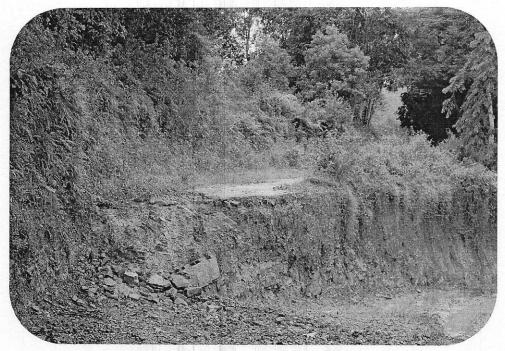
View of the old road going to the ground

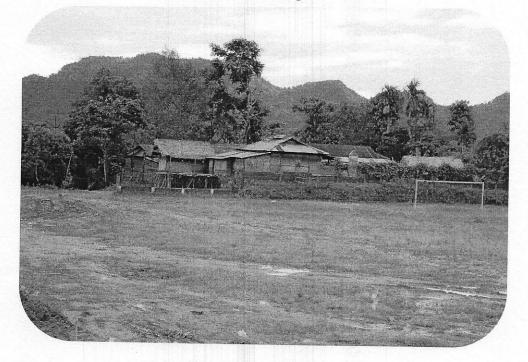
View of the old road going through the playground
