**GOVERNMENT OF INDIA  
NORTH EASTERN COUNCIL SECRETARIAT  
NONGRIM HILLS, SHILLONG – 793003**

**Subject:** Submission of Inspection Report of NEC funded project titled “**Construction of Mini Outdoor Stadium at Senapati Public Ground, Senapati District, Manipur**”.

**Report of the inspection carried on 23/03/2021 for the NEC funded project "Construction of Mini Outdoor Stadium at Senapati Public Ground, Senapati District, Manipur."**

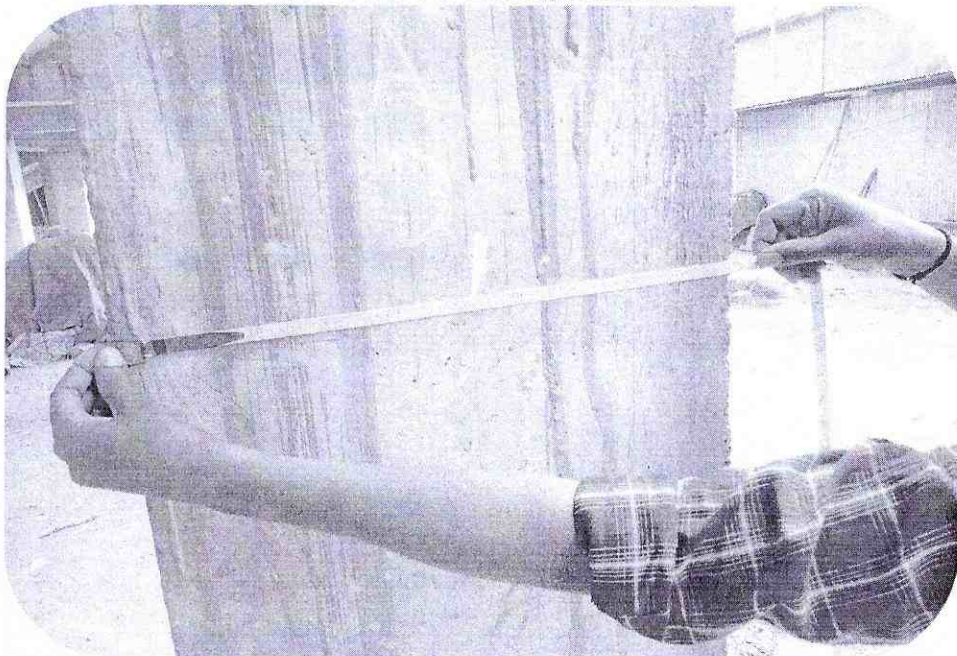
- The width of top cantilever slab and front pedestrian movement slab is less than approved DPR i.e. 1m and 1.5m.
- The area and height of the Gallery was constructed as per specification mentioned in approved DPR. The sizes of all the columns constructed at site were (0.50x0.48)m whereas in DPR 92nos of column is of (0.45x0.45)m and 4nos is of (0.6x0.6)m.

View of Gallery &  
Below is a photo showing column size

Around 60-65% of the works have been completed. However the concern sector should seek clarification regarding the anomalies mention above.

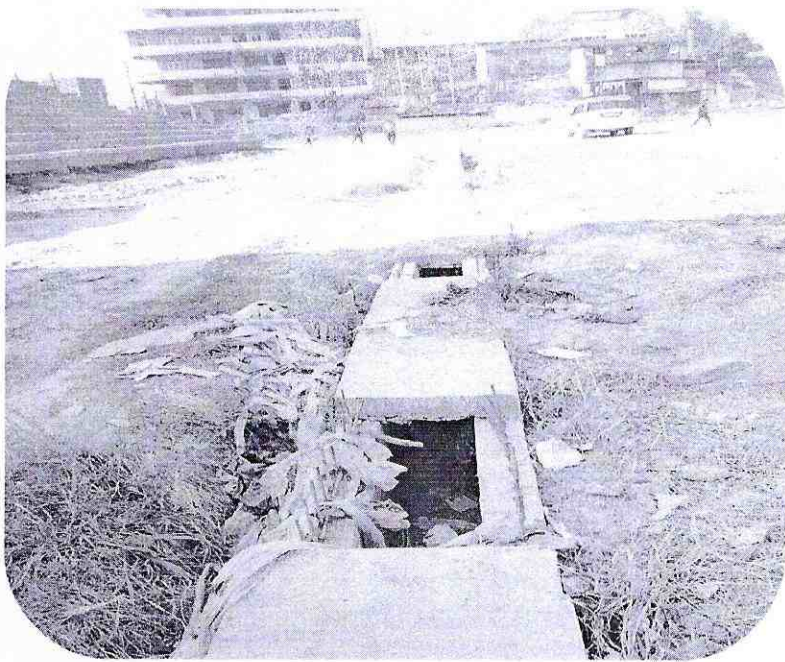
- Constructions of Football field development & drainage system is under progress. The total length of the drain constructed is 374m long more or less. The width of the drain is 0.65m which is less than the approved DPR i.e. 1m.

View of drain

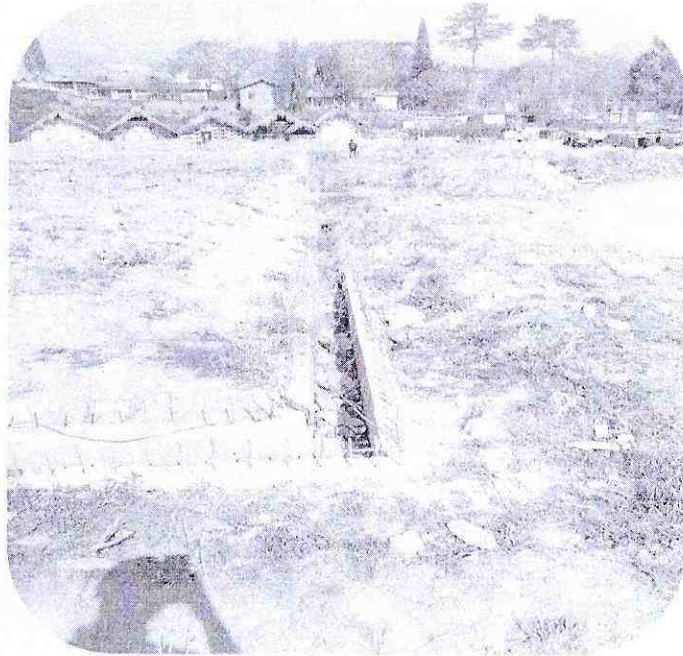
- RCC side wall have been provided instead of brick wall which is better.
- Plastering, Spreading of good earth to standard thickness in field, Turfing with good quality fresh Tingthou grass, Providing and fixing 160mm double socketed 3mt long pipes, Supplying and stacking at source / quarry of broken crushed stone aggregate and Filling of stone aggregate on lateral field works are not yet started.

View of drain construction in progress.
