**GOVERNMENT OF INDIA
NORTH EASTERN COUNCIL SECRETARIAT
NONGRIM HILLS, SHILLONG – 793003**

Subject: Forwarding of Inspection Report.

Report of the inspection carried on 09 / 02/2018 for the NEC funded project "Construction/Remodelling of RCC building including Development of Library,Vocational Centre etc.of Madhav Dev Higher Secondary School at Tulsimukh,Nagaon"

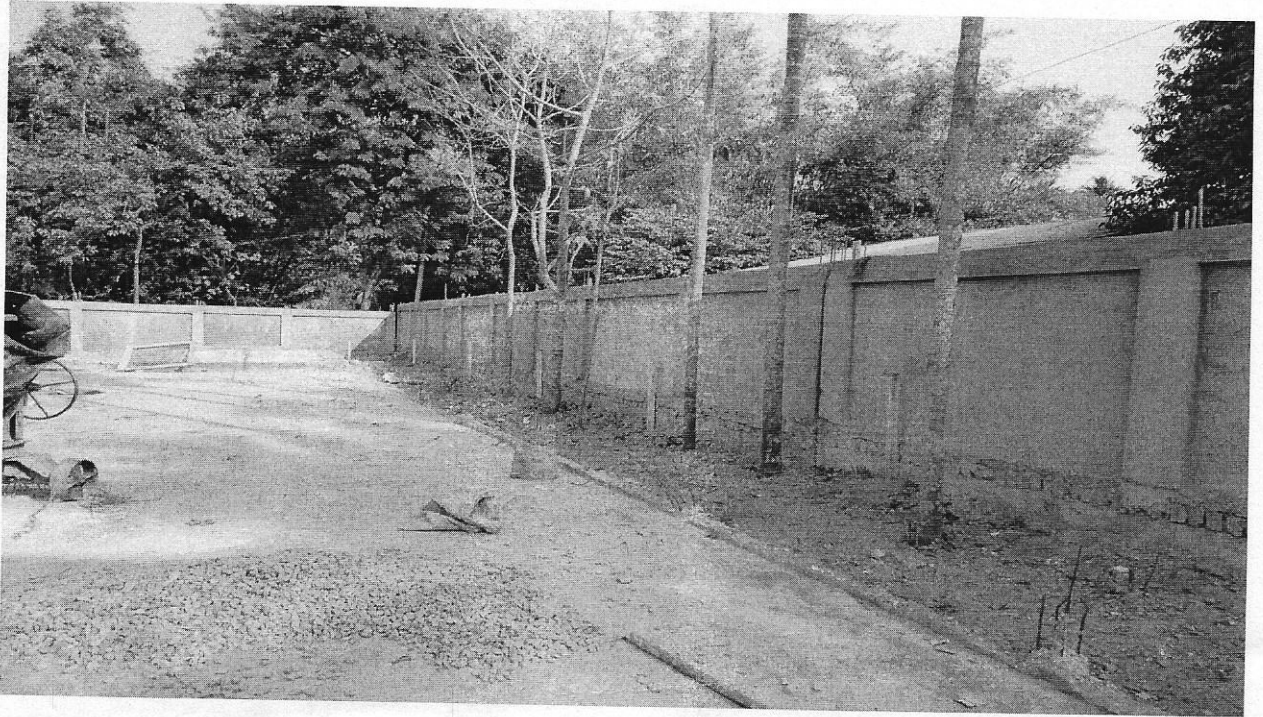
3.	Construction of boundary wall	2586050.00	During inspection it was found that total 261.65 m boundary wall constructed in the school compound. As per approved DPR total 265 m boundary wall was proposed. It could be seen that finishing work at the top portion of the pillar of the boundary wall, installing MS Grill above the brick wall, painting works not yet completed.

View of Boundary Wall at Madhav Dev Higher Secondary School in Tulsimukh

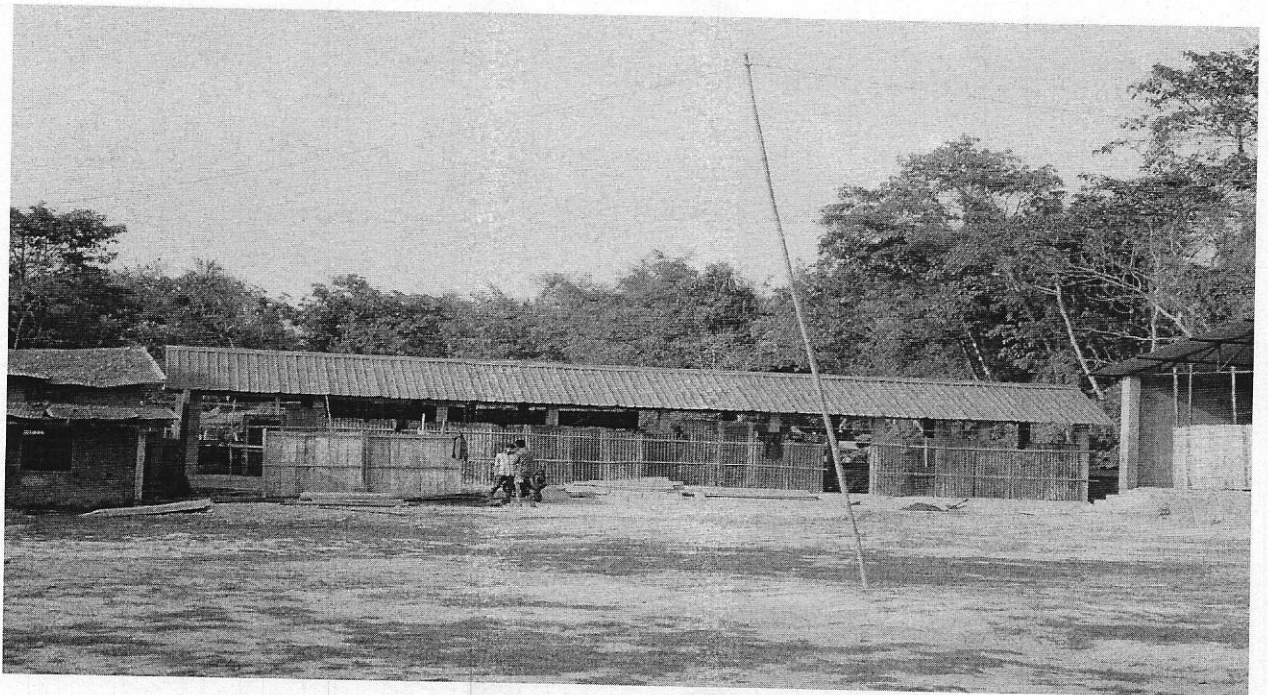
2.	Construction of Cycle Stand	642518.00	Construction of Cycle Stand already completed except painting works of truss and building portion and putting checkered tiles in the ramp section. It was found that Cycle Stand had been constructed as per approved DPR dimensions.

View of Cycle Stand at Madhav Dev Higher Secondary School in Tulsimukh

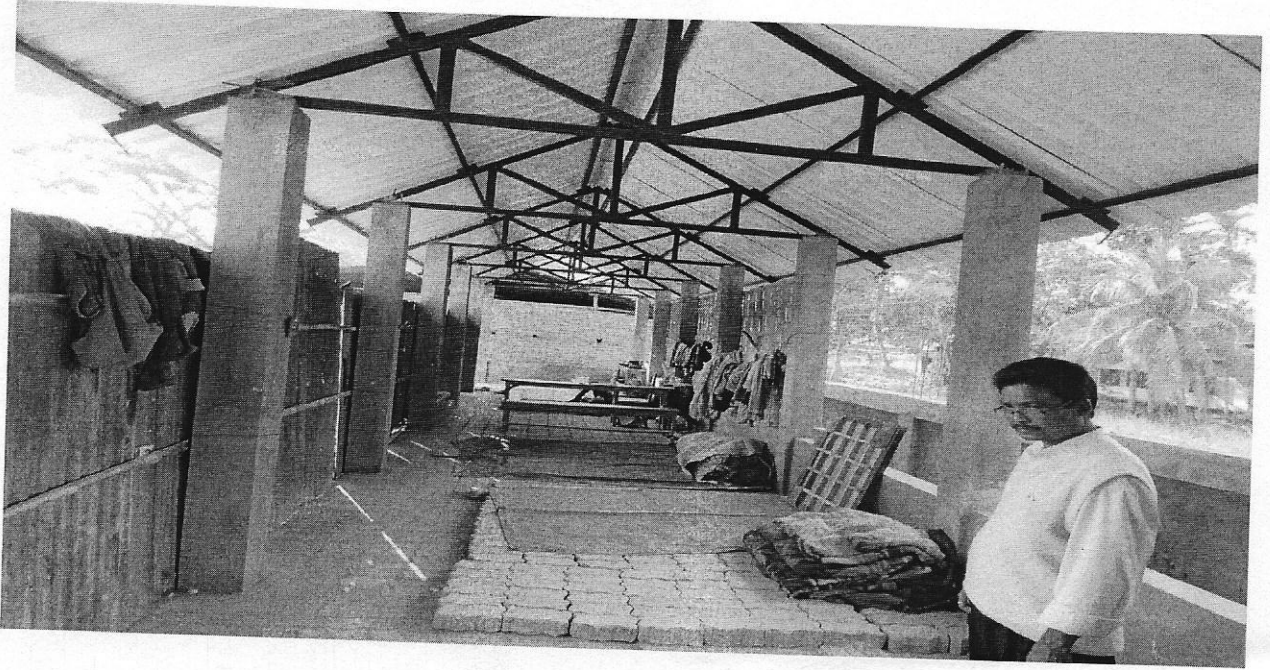
Inside view of Cycle Stand at Madhav Dev Higher Secondary School

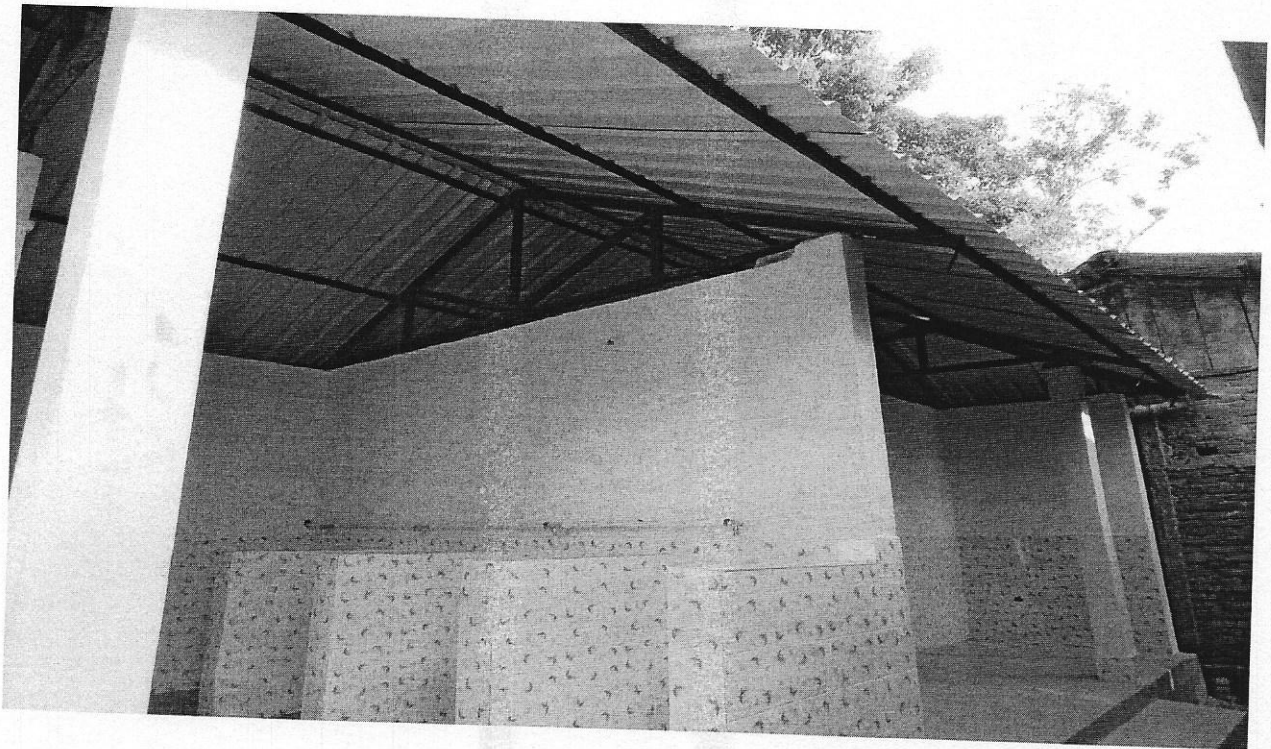
6.	Construction of outside toilet block	1017483.00	Construction of toilet block completed except painting works of truss and construction of two more wash basin. Total Plinth area of 38.13 sqm. was proposed in

the approved DPR., but 35.874 sqm. toilet block was found constructed.
7.	Repairing /Maintenance of existing Assam type building	257282.00	Not yet done.

View of Toilet Block at Madhav Dev Higher Secondary School

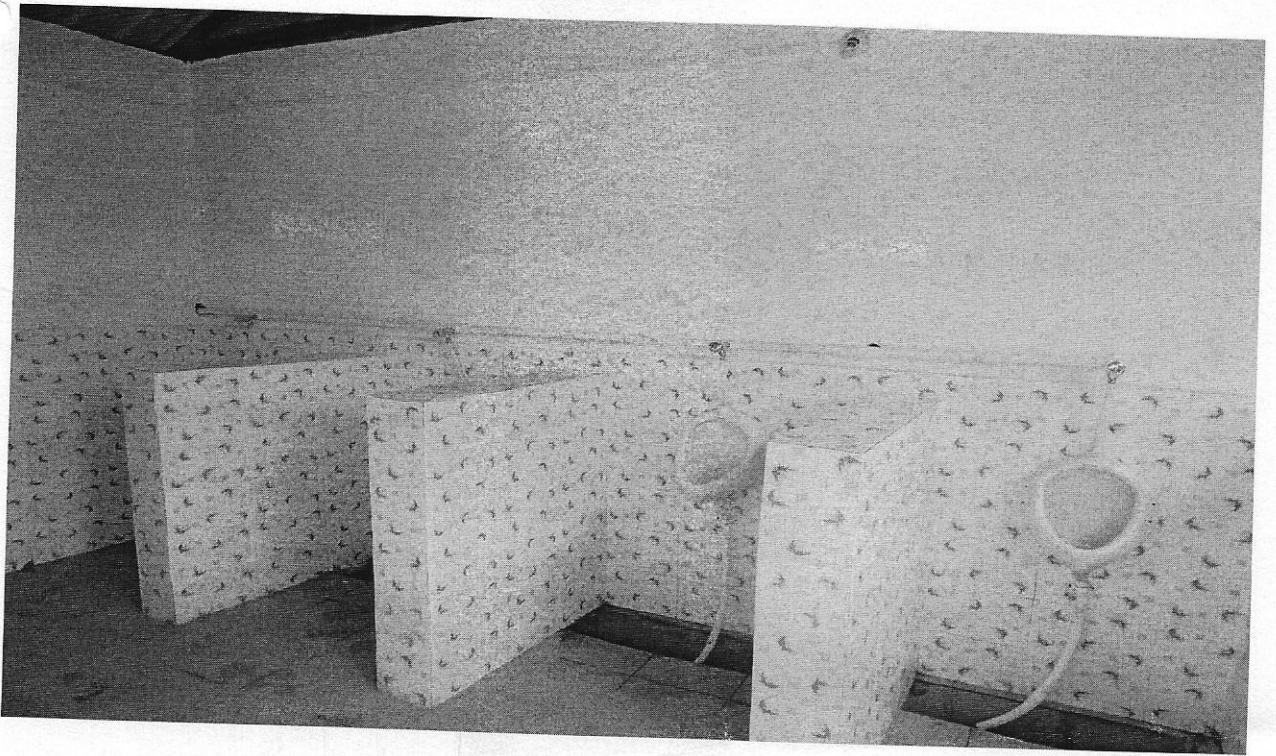
Inside view of Toilet Block at Madhav Dev Higher Secondary School

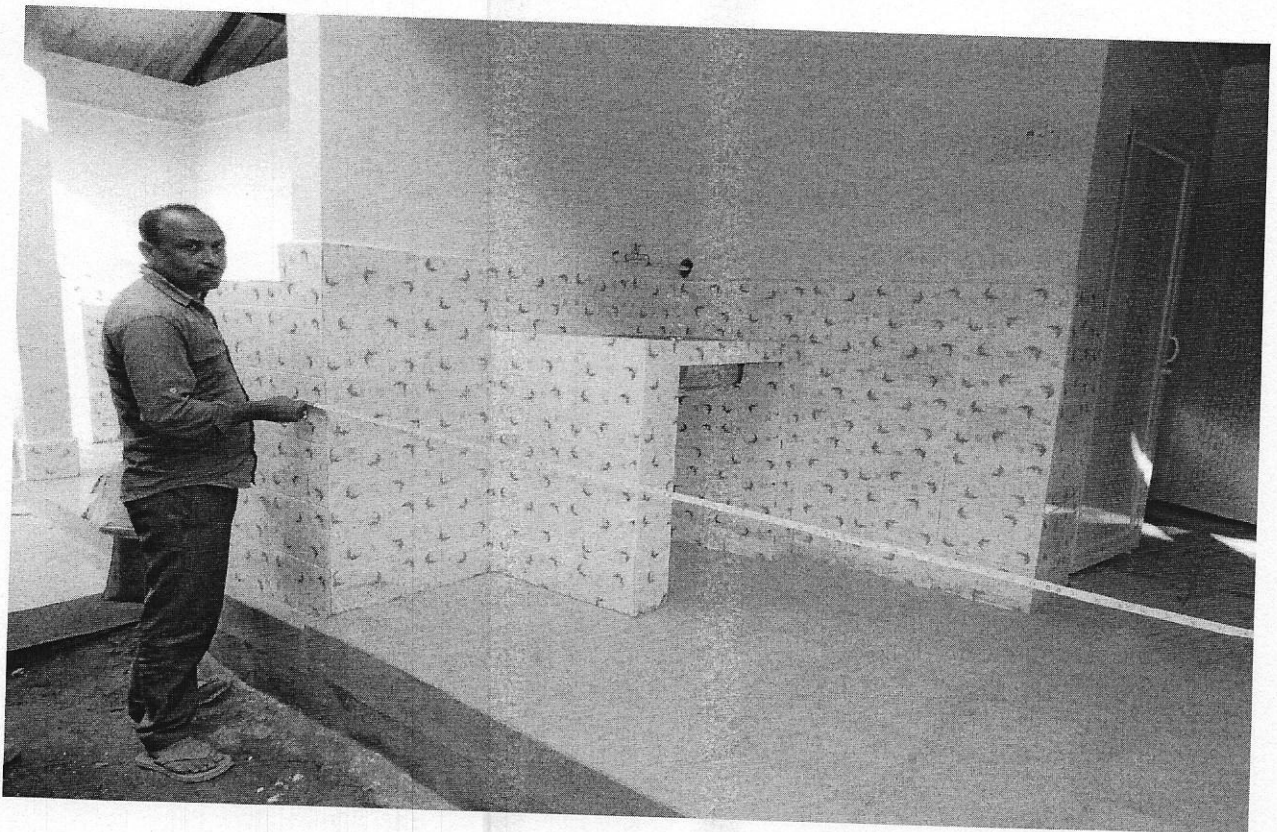
Mesurement taking at Toilet Block of Madhav Dev Higher Secondary School

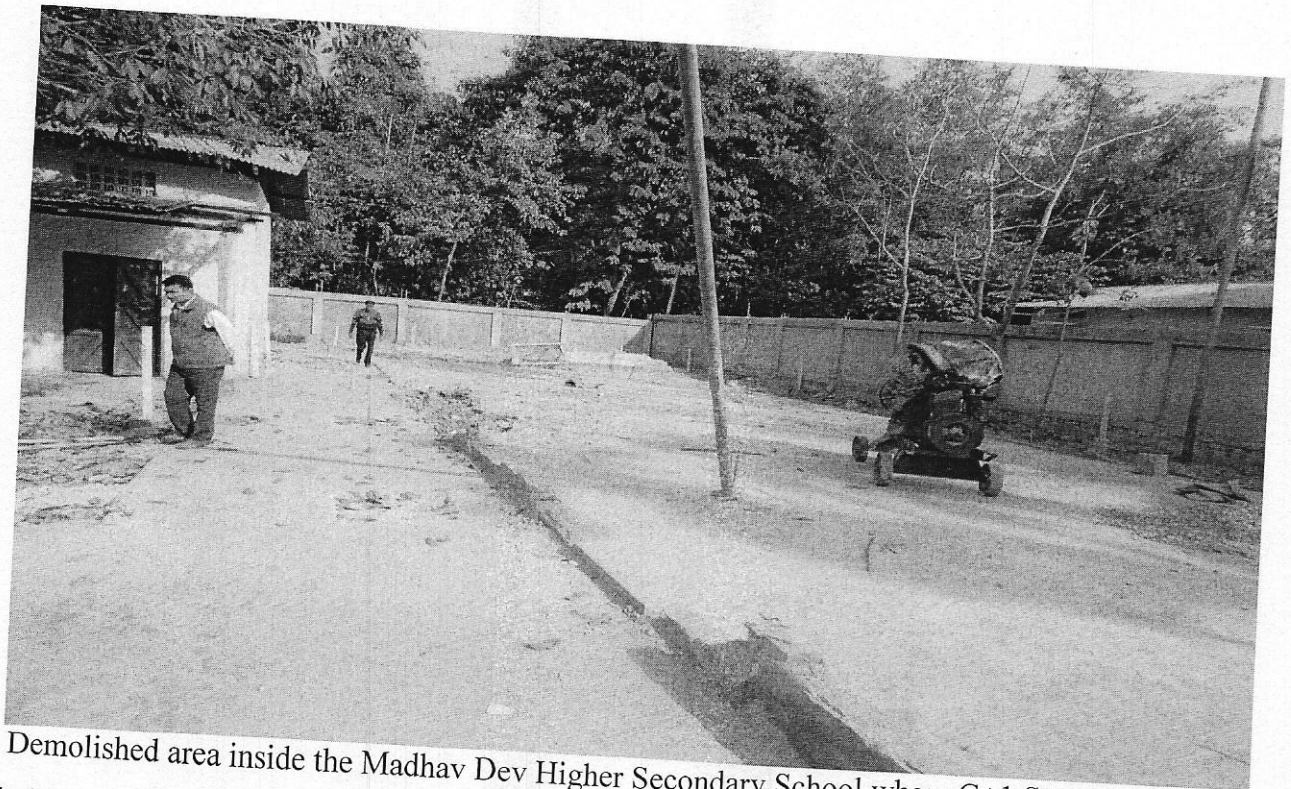
Sl.No.	Description of Item	Amount approved by NEC (in Rs.)	Remarks based on site Inspection
1.	Construction of G+1 storied RCC school building	20672937.00	It could be seen that construction of G+1 storied RCC building was not started yet, it was also observed that half of the old school building structure already demolished. Implementing department informed that within this week pile work would be started in the demolished portion.

Demolished area inside the Madhav Dev Higher Secondary School where G+1 Storied schhol building will be constructed.
